## CONDITION REPORT

2017303392

| Manufacturer | HYUNDAI | Registration Number | FL40TDGP |
| Model | ACCENT 1.6 FLUID 6-SP [2013-2021] | Register Number | |

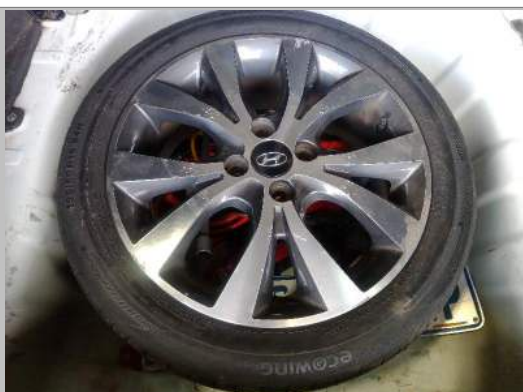
General Comments: ACCORDING TO THE AGE AND MILEAGE OF THE VEHICLE, NORMAL WEAR AND TEAR MARKS ARE VISIBLE ON THE INTERIOR, EXTERIOR, ELECTRICAL AND MECHANICAL PARTS. Interior: Vehicle interior dirty and panels scratched.  
Body • Exterior: Dents and scratches on body panels  
Tyres and Rims: Spare Wheel deflated.

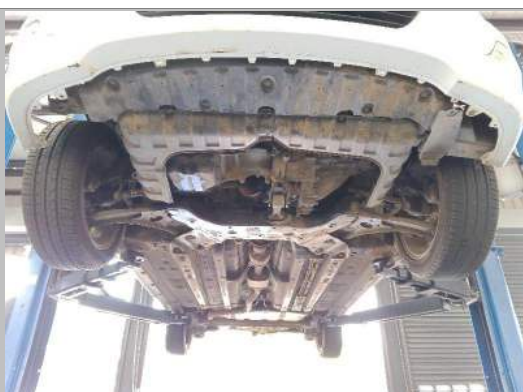
Front chassis

| Chassis Dented | Repair |

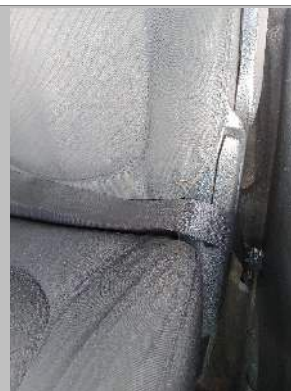
| Seat Front Right Damaged | Repair |
