CONDITION REPORT

Report No: 2016488292

MFC Auction House  
M57 Pretoria Rd, Glenmarais, KEMPTON PARK  
Gauteng

| Manufacturer | HYUNDAI | Registration Number | FH64YBGP |

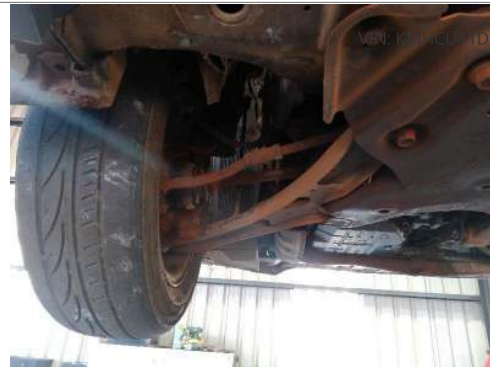
LF TYRE TREAD

| Damage | Repair Way |
|---|---|
| Tyre Front Left Worn | Replace |

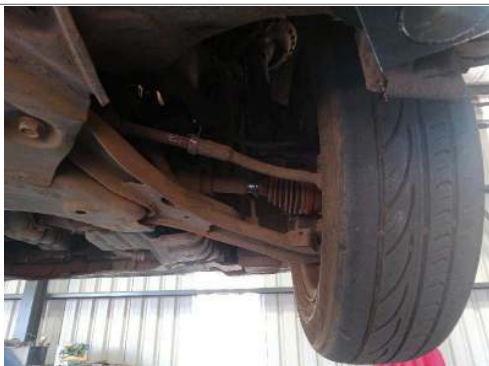
RF TYRE TREAD

| Damage | Repair Way |
|---|---|
| Tyre Front Right Worn | Replace |

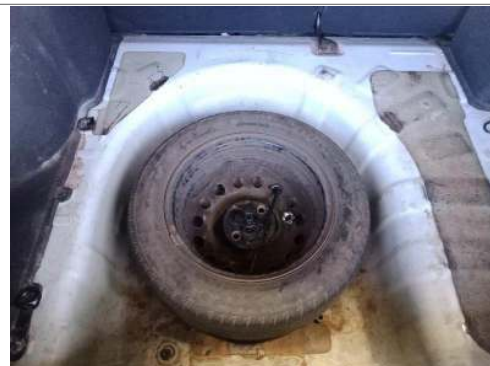
Spare wheel

| Damage | Repair Way |
|---|---|
| Spare Tyre Torn / Cut | Replace |

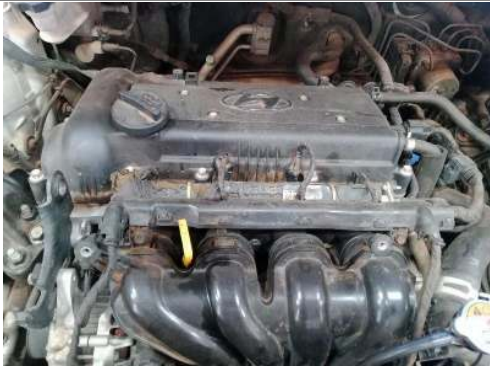
| Damage | Repair Way |
|---|---|
| Engine | Injector rail insulation cover damaged |

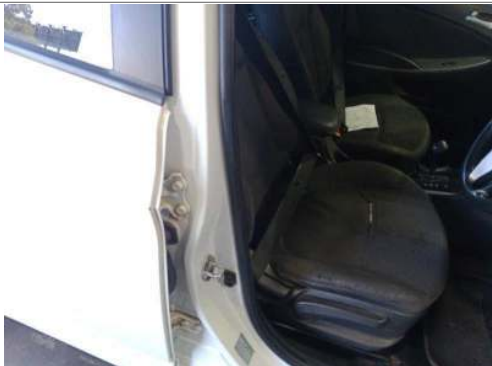
| Damage | Repair Way |
|---|---|
| Door Sealing Rubber Front Right Damaged | Replace |

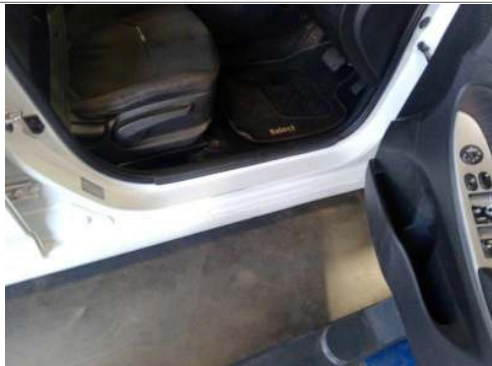
| Damage | Repair Way |
|---|---|
| Sill Panel Right Paintwork • Scratched | Repair |

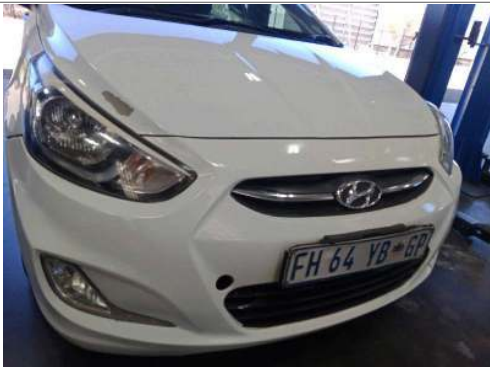
| Damage | Repair Way |
|---|---|
| Front Bumper Damaged | Replace |

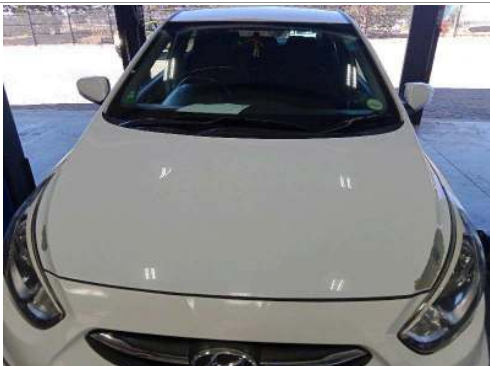
| Damage | Repair Way |
|---|---|
| Bonnet Paintwork • Flaking | Repair |

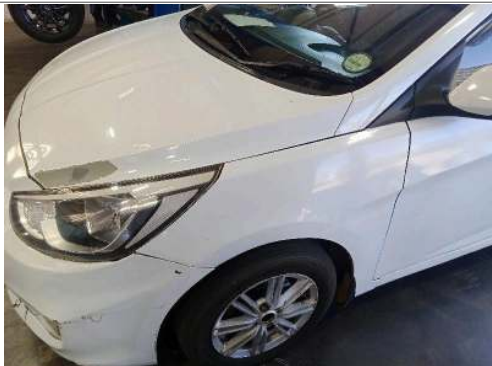
| Damage | Repair Way |
|---|---|
| Front Fender Left Residual Traces of Repair | Repair |

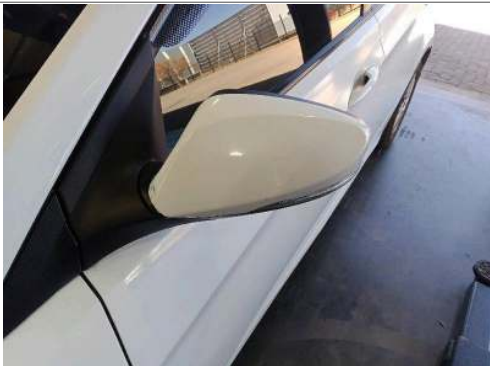
| Damage | Repair Way |
|---|---|
| Side Mirror Left Residual Traces of Repair | Repair |

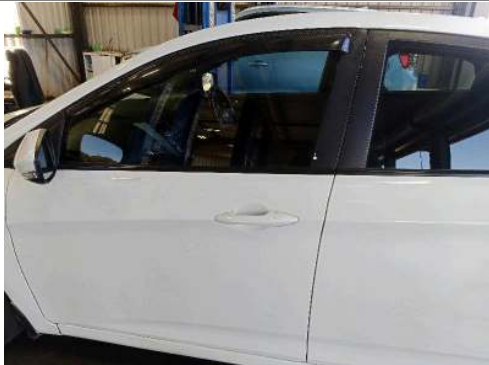
| Damage | Repair Way |
|---|---|
| Door Front Left Residual Traces of Repair | Repair |

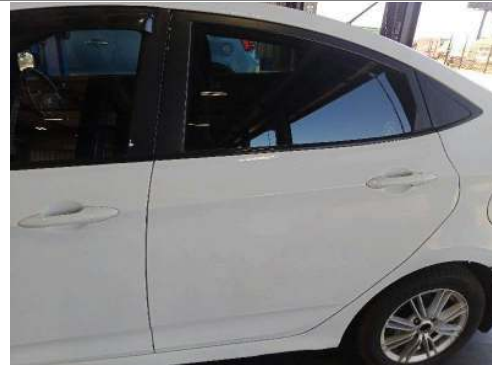
| Damage | Repair Way |
|---|---|
| Door Rear Left Residual Traces of Repair | Repair |

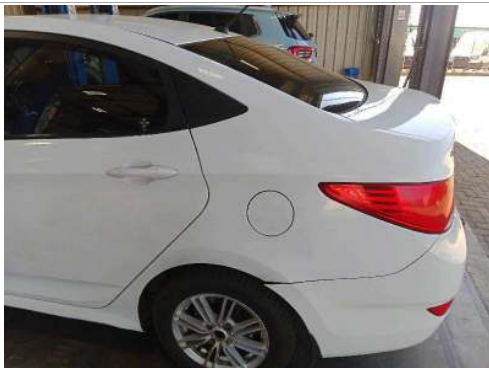
| Damage | Repair Way |
|---|---|
| Rear Fender Left Residual Traces of Repair | Repair |

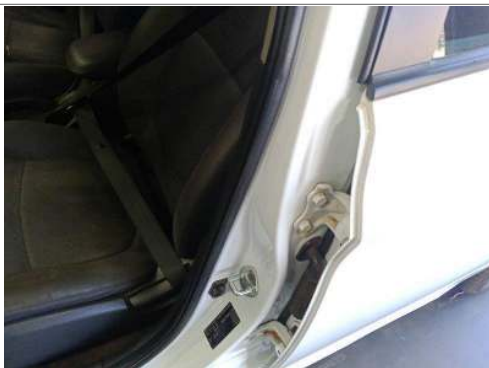
| Damage | Repair Way |
|---|---|
| Door Sealing Rubber Front Left Torn / Cut | Replace |

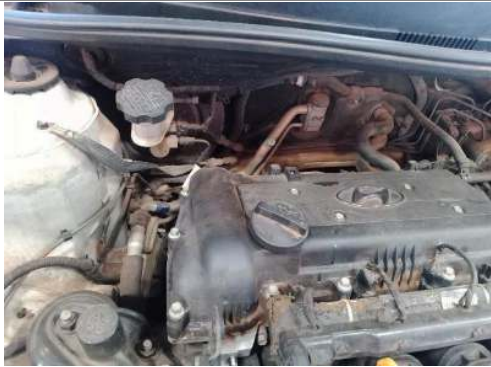
| Damage | Repair Way |
|---|---|
| Engine | Engine bay dirty and battery loose |

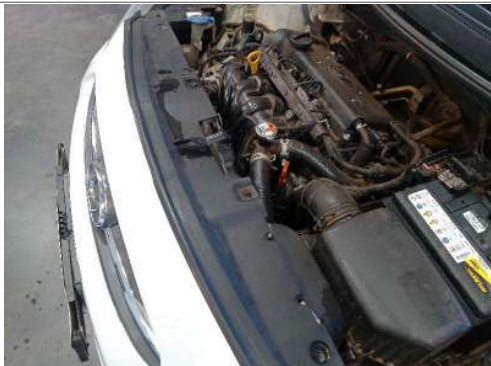
| Damage | Repair Way |
|---|---|
| Bonnet slam plate (Shock tower/ Inner tray) Cracked | Repair |

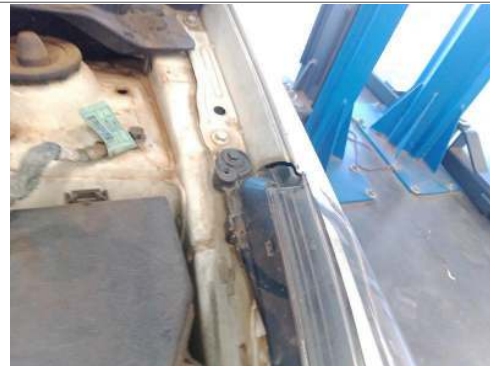
| Damage | Repair Way |
|---|---|
| Headlight Left Defective | Replace |

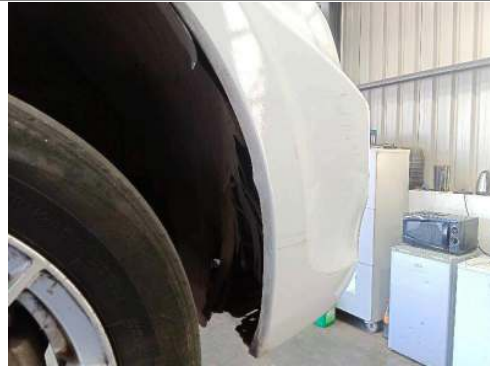
| Damage | Repair Way |
|---|---|
| Front Fender Right / Inner Tray Damaged | Replace |

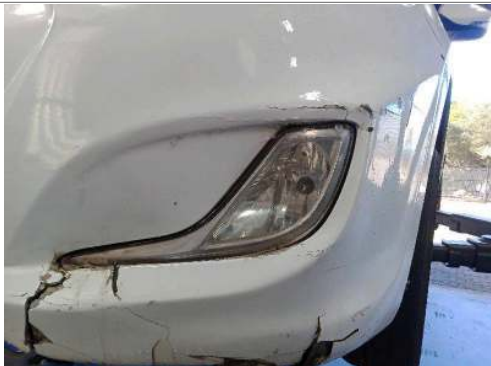
| Damage | Repair Way |
|---|---|
| Fog Light Front Left Defective | Replace |

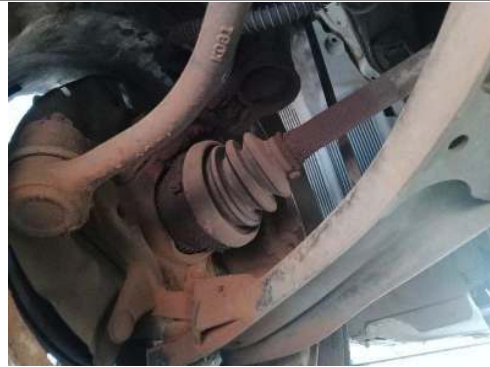
| Damage | Repair Way |
|---|---|
| CV Joint(s) Boot(s) Front Left (inner/outer) Damaged | Replace |

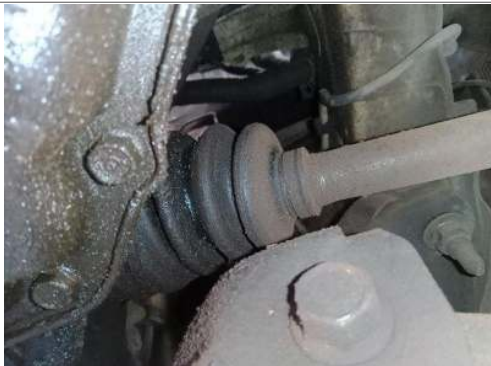
| Damage | Repair Way |
|---|---|
| CV Joint(s) Boot(s) Front Right (inner/outer) Damaged | Replace |

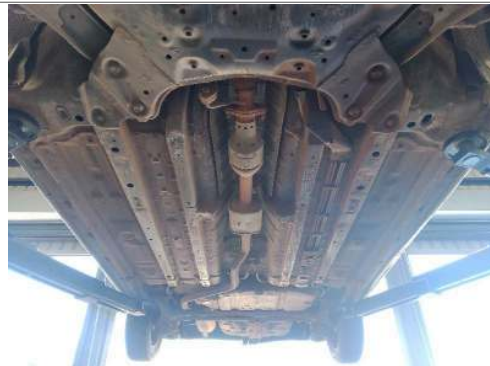
| Damage | Repair Way |
|---|---|
| Chassis Damaged | Repair |

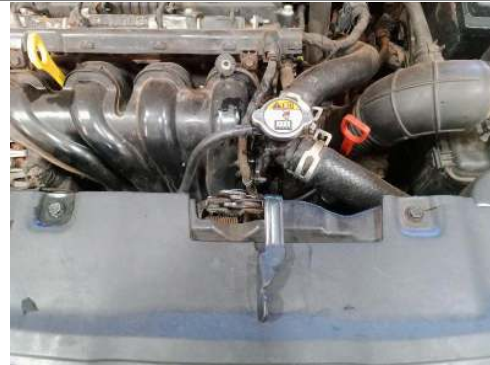
| Damage | Repair Way |
|---|---|
| Bonnet safety caps Defective | Repair |
