MFC Auction House  
M57 Pretoria Rd, Glenmarais, KEMPTON PARK  
Gauteng

DEKRA MFC  
M57 Pretoria Rd - 1619  
KEMPTON PARK - GT  
08610 33572

| Manufacturer | HYUNDAI | Registration Number | KK85YGGP |
| Model | ELANTRA | Register Number | |

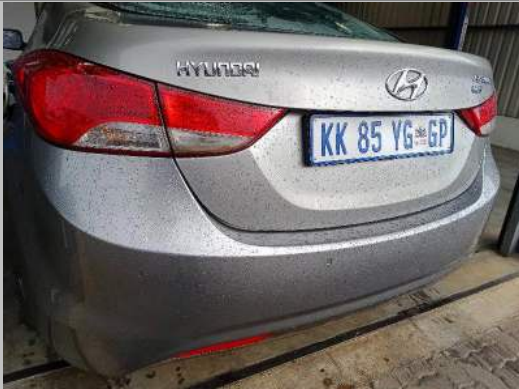
| Damage | Repair Way |
|---|---|
| Rear bumper Damaged | Repair |
| Body and Exterior | Signs of impact damage to rear of vehicle |

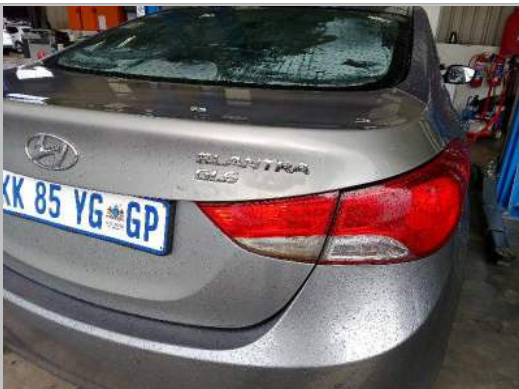
| Damage | Repair Way |
|---|---|
| Boot Lid / Hatch door Damaged | Repair |

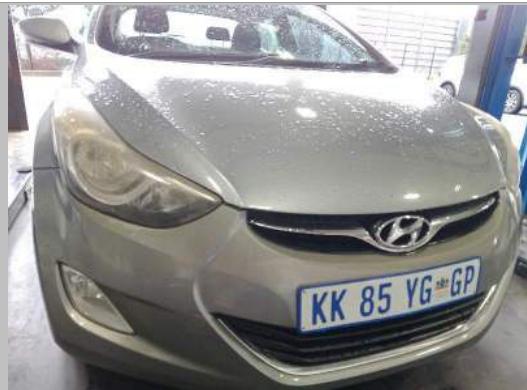
| Damage | Repair Way |
|---|---|
| Front Bumper Damaged | Repair |

| Damage | Repair Way |
|---|---|
| Body and Exterior | Signs of impact damage to front of vehicle |

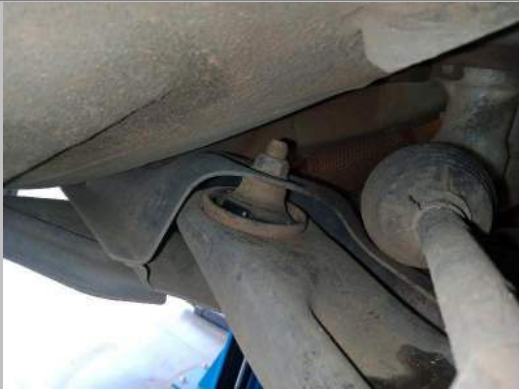
| Damage | Repair Way |
|---|---|
| Sill Panel Right Damaged | Repair |

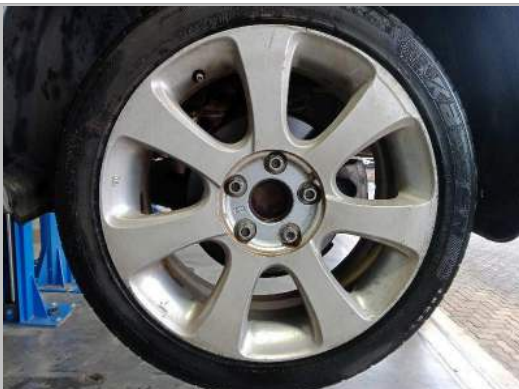
| Damage | Repair Way |
|---|---|
| Rim Rear Right Scratched | Repair |

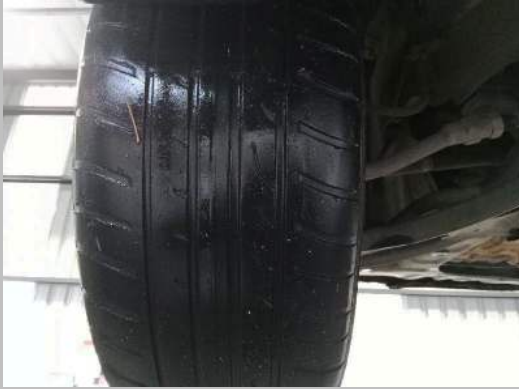
| Damage | Repair Way |
|---|---|
| Tyre Front Right Damaged | Replace |

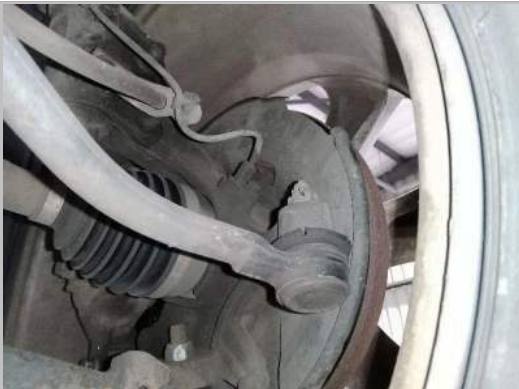
| Damage | Repair Way |
|---|---|
| Tie Rod End left Damaged | Replace |

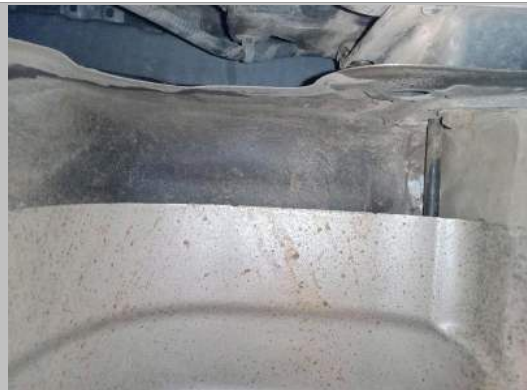
| Damage | Repair Way |
|---|---|
| Silencer Damaged | Replace |

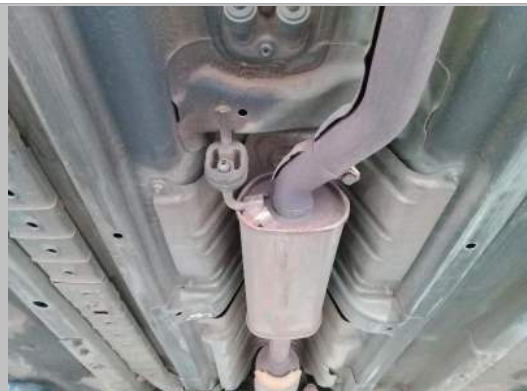
| Damage | Repair Way |
|---|---|
| Engine to silencer pipe Damaged | Repair |
