## CONDITION REPORT

2017304207

| Manufacturer | KIA | Registration Number | BF62DDZN |
| Model | RIO | Register Number | |

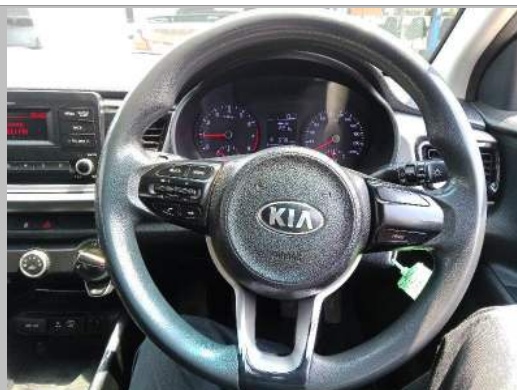
| Damage | Repair Way |
|---|---|
| Steering Wheel Trim Excessive Wear & Tear | Repair |

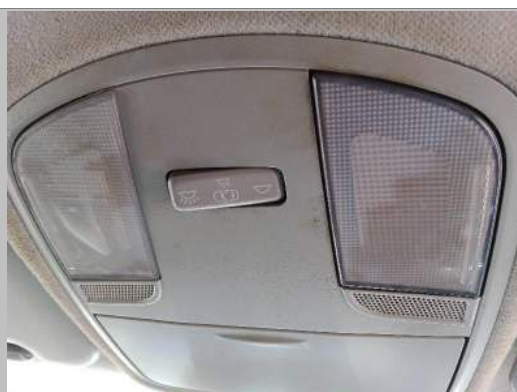
| Damage | Repair Way |
|---|---|
| Interior Lights Damaged | Replace |

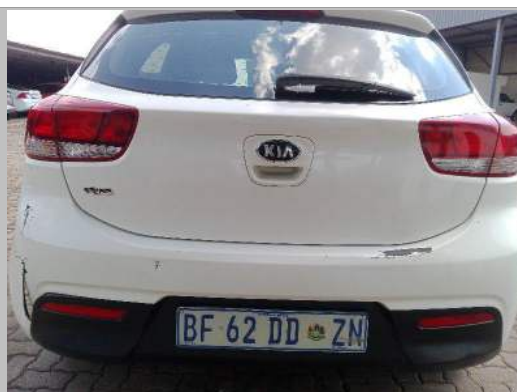
| Damage | Repair Way |
|---|---|
| Rear bumper Damaged | Replace |

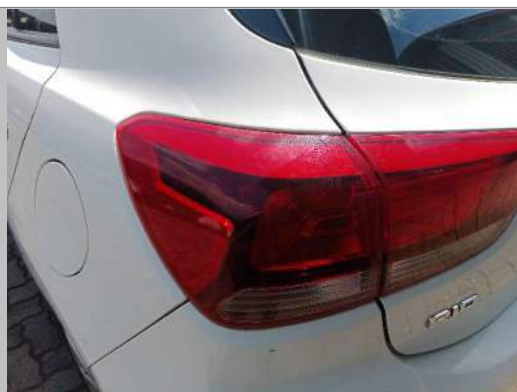
| Damage | Repair Way |
|---|---|
| Tail Light Left Scratched | Repair |

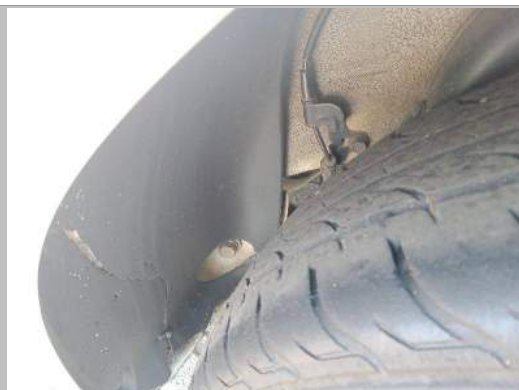
| Damage | Repair Way |
|---|---|
| Rear Fender Left / Inner Tray Damaged | Replace |

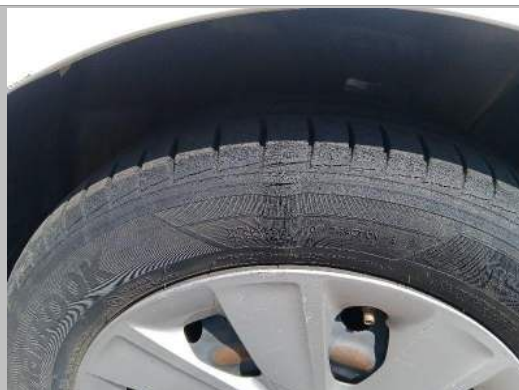
| Damage | Repair Way |
|---|---|
| Tyre Front Right Damaged | Replace |

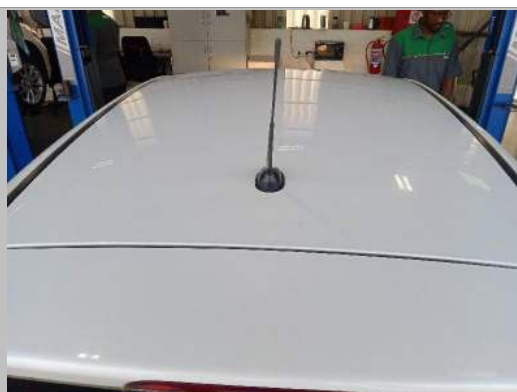
| Damage | Repair Way |
|---|---|
| Roof Dented | Repair |

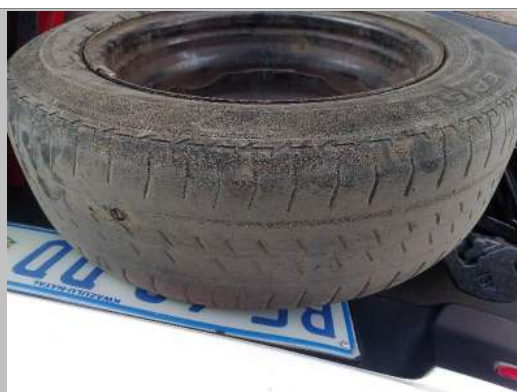
| Damage | Repair Way |
|---|---|
| Spare Tyre Damaged | Replace |

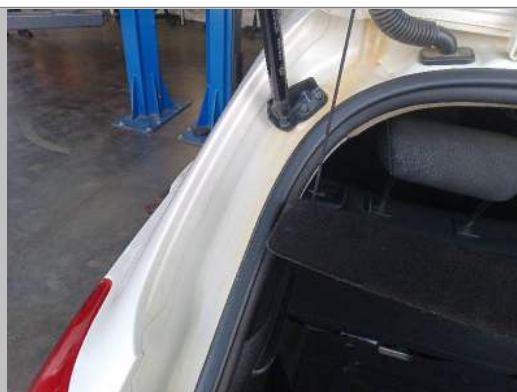
| Damage | Repair Way |
|---|---|
| C • Pillar Left Defective | Repair |

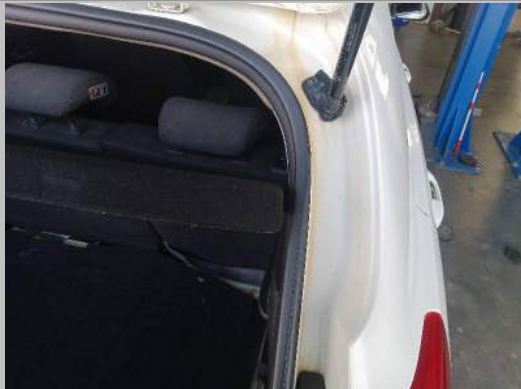
| Damage | Repair Way |
|---|---|
| C • Pillar Right Defective | Repair |

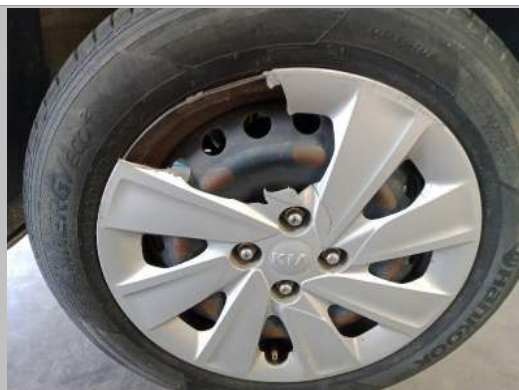
| Damage | Repair Way |
|---|---|
| Rim Front Right Dented | Repair |

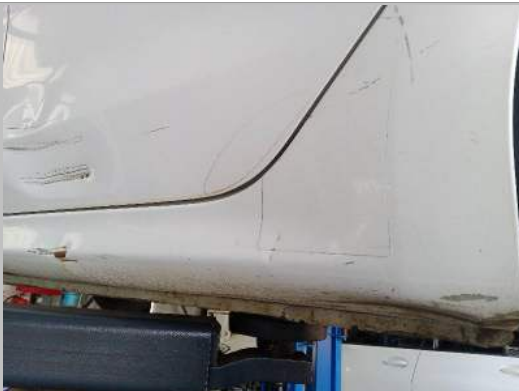
| Damage | Repair Way |
|---|---|
| Sill Panel Left Damaged | Repair |

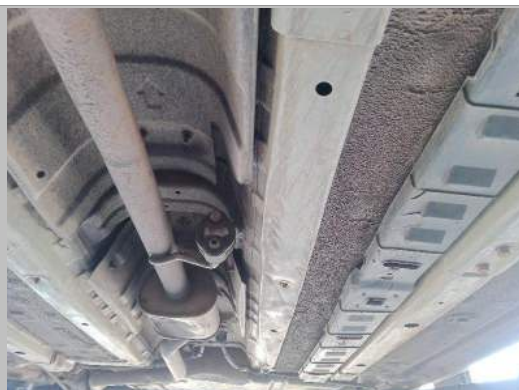
| Damage | Repair Way |
|---|---|
| Chassis Damaged | Repair |

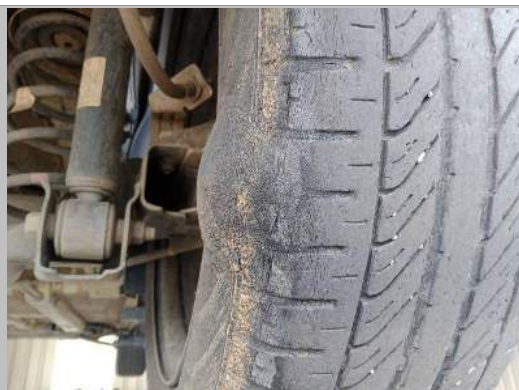
| Damage | Repair Way |
|---|---|
| Tyre Rear Right Damaged | Replace |
| Rear left and right tyre sizes different | Repair |

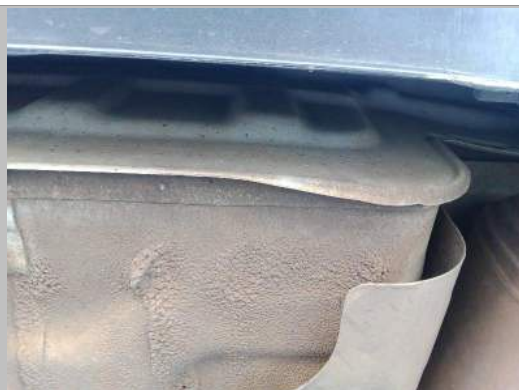
| Damage | Repair Way |
|---|---|
| Inner Boot Floor Pan and Spare Wheel Well Dented | Repair |
