MFC Auction House  
M57 Pretoria Rd, Glenmarais, KEMPTON PARK  
Gauteng

| Manufacturer | GWM | Registration Number | FB19RHGP |

## CONDITION REPORT

Report No: 2016226947

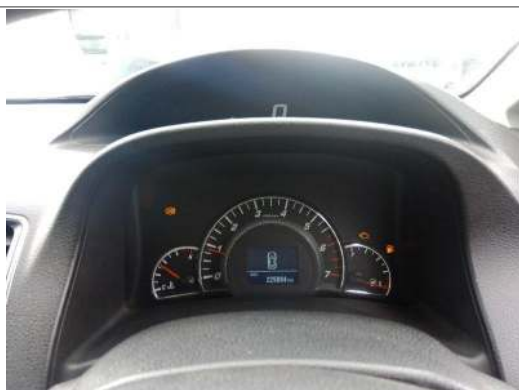
DASHBOARD (W/ ENGINE RUNNING)

| Damage | Repair Way |
|---|---|
| Warning lights illuminated on dashboard. | Repair |

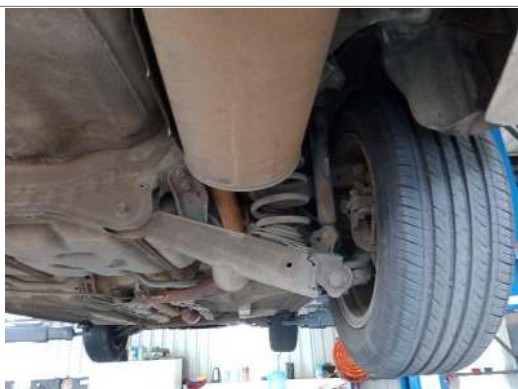
RR TYRE TREAD

| Damage | Repair Way |
|---|---|
| Tyre Rear Right Damaged | Replace |

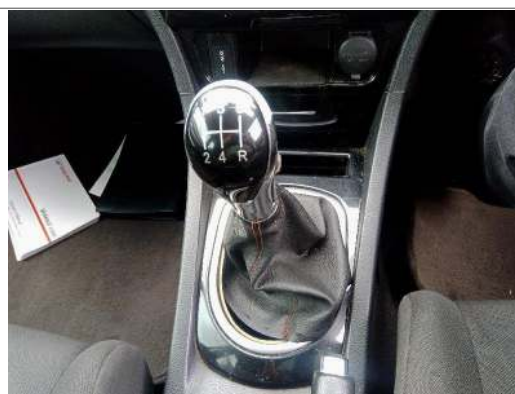
Manual Transmission

| Damage | Repair Way |
|---|---|
| Gearbox Oil Leak | Repair |

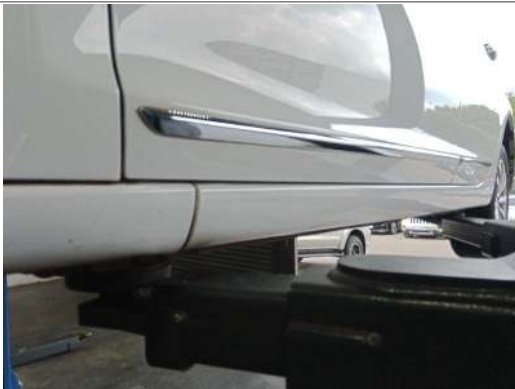
| Damage | Repair Way |
|---|---|
| Rocker Panel Left Dented | Repair |

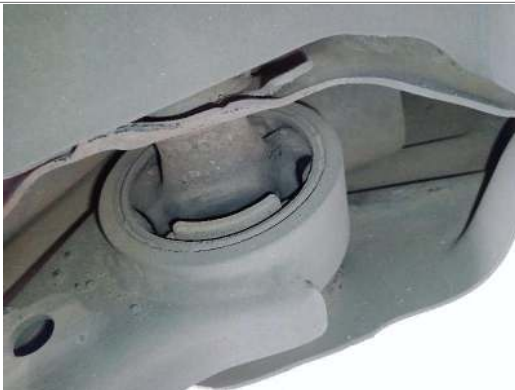
| Damage | Repair Way |
|---|---|
| Control Arm Bush(es) Front Axle Right Cracked | Replace |

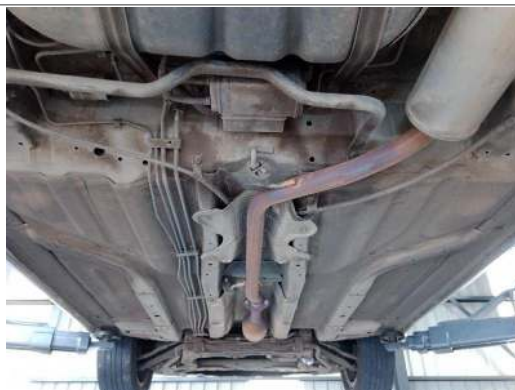
| Damage | Repair Way |
|---|---|
| Chassis Scratched | Repair |

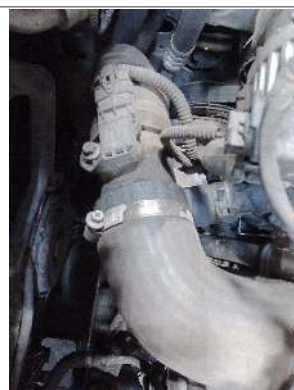
| Damage | Repair Way |
|---|---|
| Hoses Oil Leak | Repair |
