CONDITION REPORT

Report No: 2016363150

MFC Auction House  
M57 Pretoria Rd, Glenmarais, KEMPTON PARK  
Gauteng

| Manufacturer | HYUNDAI | Registration Number | HJ93PPGP |

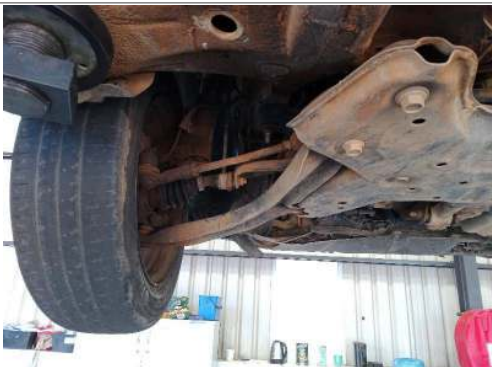
LF TYRE TREAD

| Damage | Repair Way |
|---|---|
| Tyre Front Left Worn | Replace |

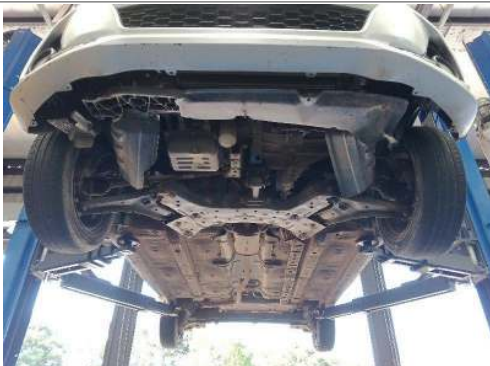
Front chassis

| Damage | Repair Way |
|---|---|
| Chassis Dented | Repair |

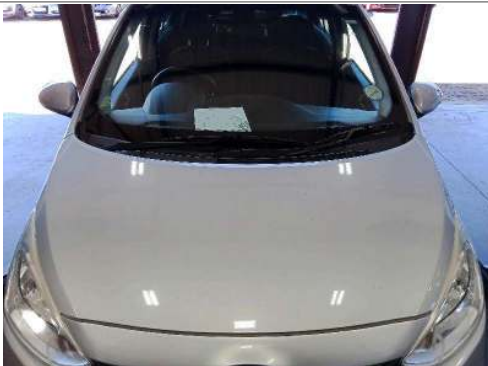
| Damage | Repair Way |
|---|---|
| Bonnet Paintwork • Chipmarks | Repair |

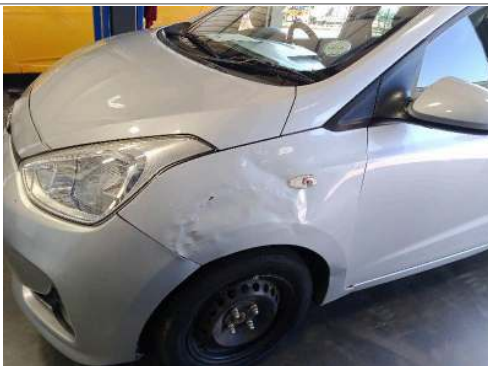
| Damage | Repair Way |
|---|---|
| Front Fender Left Damaged | Repair |

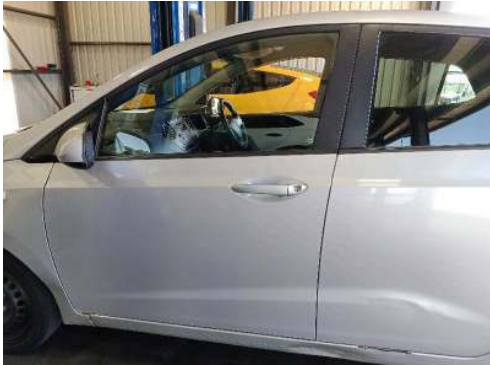
| Damage | Repair Way |
|---|---|
| Door Front Left Paintwork • Scratched | Repair |

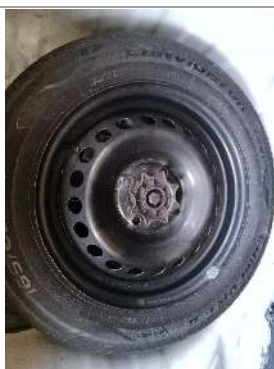
| Damage | Repair Way |
|---|---|
| Rim Spare Wheel Dented | Repair |

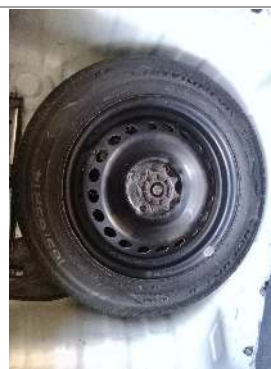
| Damage | Repair Way |
|---|---|
| Spare Tyre Defective | Replace |

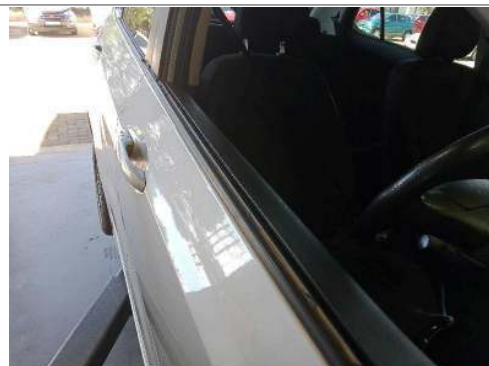
| Damage | Repair Way |
|---|---|
| Weather Strip Door Front Right Damaged | Replace |
