MFC Auction House  
M57 Pretoria Rd, Glenmarais, KEMPTON PARK  
Gauteng

DEKRA MFC  
M57 Pretoria Rd - 1619  
KEMPTON PARK - GT  
08610 33572

## Assignment

| Manufacturer | HYUNDAI | Registration Number | CY34JNGP |

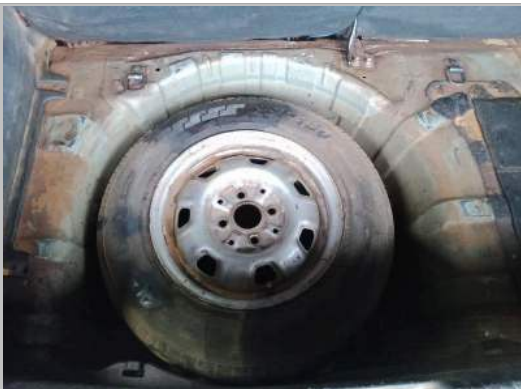
Spare wheel

| Damage | Repair Way |
|---|---|
| Spare Tyre Damaged | Replace |

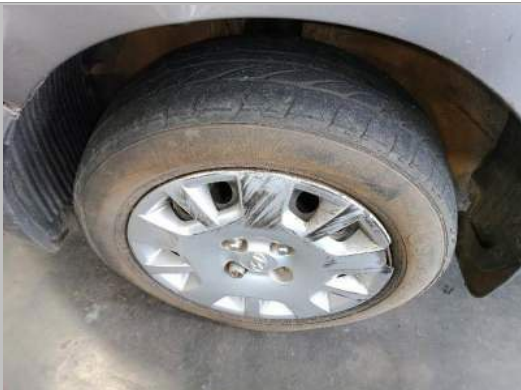
Front left hubcap

| Damage | Repair Way |
|---|---|
| Tyres and rims | Front left and right hubcaps damaged |

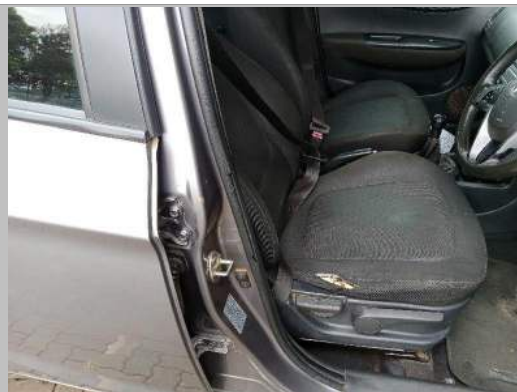
| Damage | Repair Way |
|---|---|
| Door Sealing Rubber Front Right Damaged | Replace |

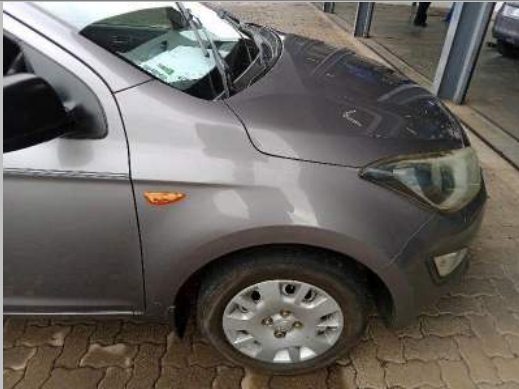
| Damage | Repair Way |
|---|---|
| Front Fender Right Dented | Repair |

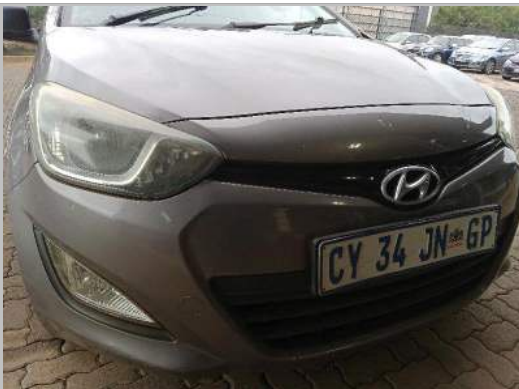
| Damage | Repair Way |
|---|---|
| Front Bumper Damaged | Repair |

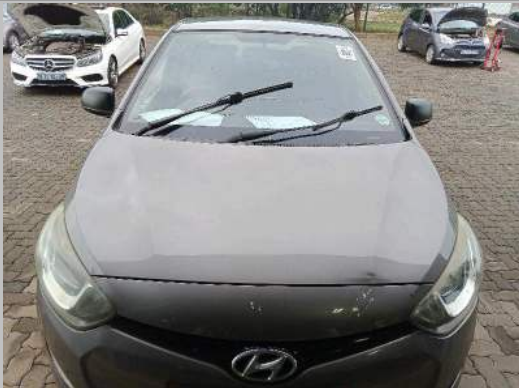
| Damage | Repair Way |
|---|---|
| Bonnet Damaged | Repair |

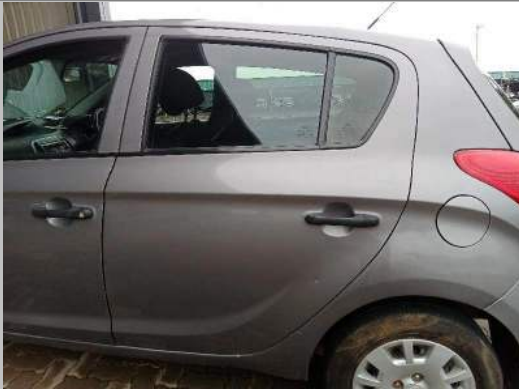
| Damage | Repair Way |
|---|---|
| Door Rear Left Damaged | Repair |

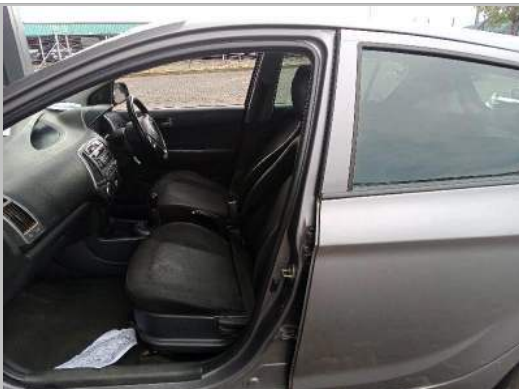
| Damage | Repair Way |
|---|---|
| B • Pillar Left Residual Traces of Repair | Repair |

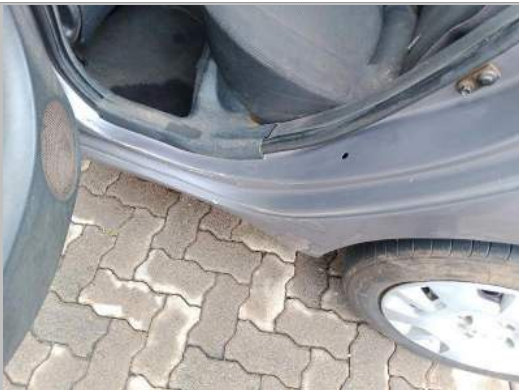
| Damage | Repair Way |
|---|---|
| Sill Panel Left Residual Traces of Repair | Repair |

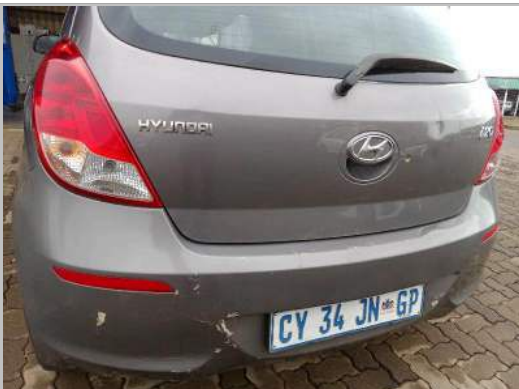
| Damage | Repair Way |
|---|---|
| Rear bumper Damaged | Repair |

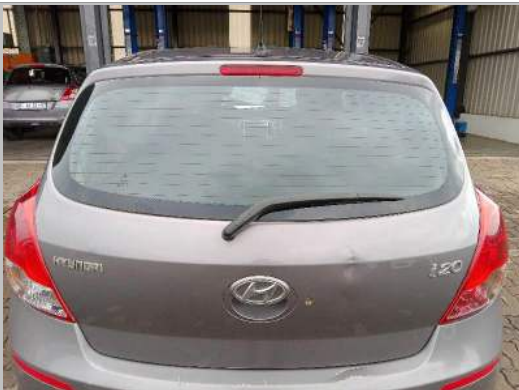
| Damage | Repair Way |
|---|---|
| Boot Lid / Hatch door Damaged | Repair |

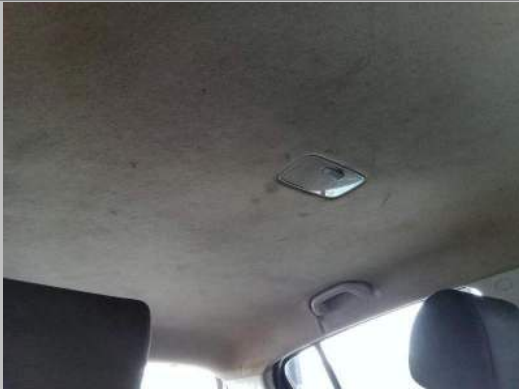
| Damage | Repair Way |
|---|---|
| Hood Lining Dirty | Repair |

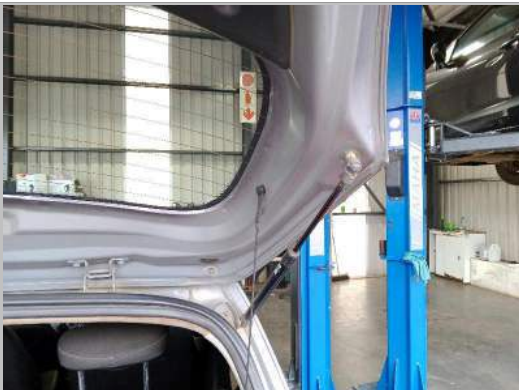
| Damage | Repair Way |
|---|---|
| Boot Lid / Hatch Door Shock Right Damaged | Replace |

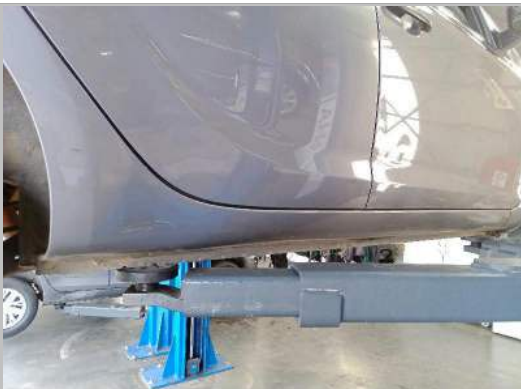
| Damage | Repair Way |
|---|---|
| Sill Panel Right Paintwork • Scratched | Repair |

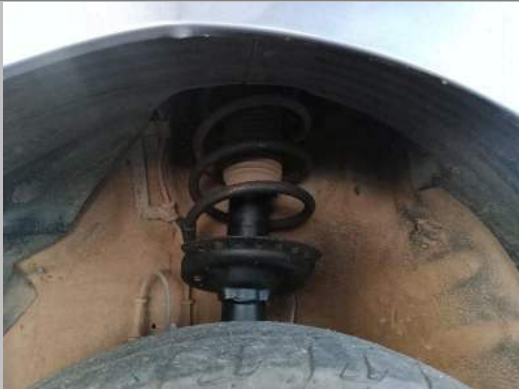
| Damage | Repair Way |
|---|---|
| Shock Absorber Front Left Leak | Replace |

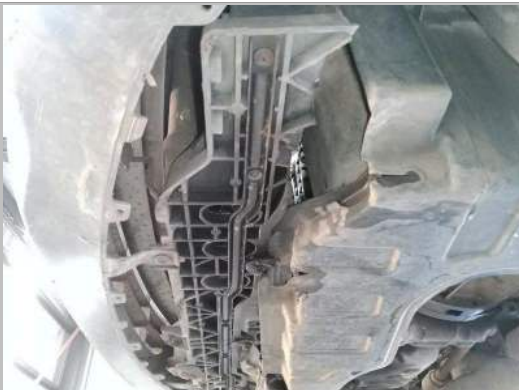
| Damage | Repair Way |
|---|---|
| Belly plates Damaged | Replace |

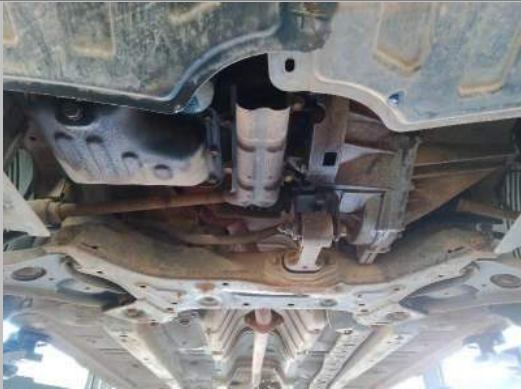
| Damage | Repair Way |
|---|---|
| Gearbox Oil Sweat | Repair |

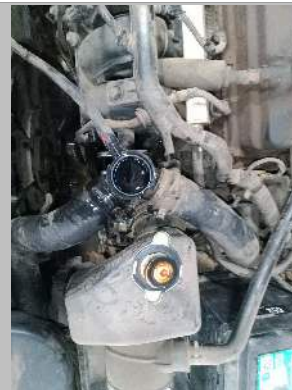
| Damage | Repair Way |
|---|---|
| Caps Damaged | Replace |
