## CONDITION REPORT

Report No:  
2016962855  
DATE  
30/07/2025

| Manufacturer | HYUNDAI | Registration Number | BT89BSGP |
| Model | I20 1.4 GL 5-DR [2009-2013] | Register Number | |

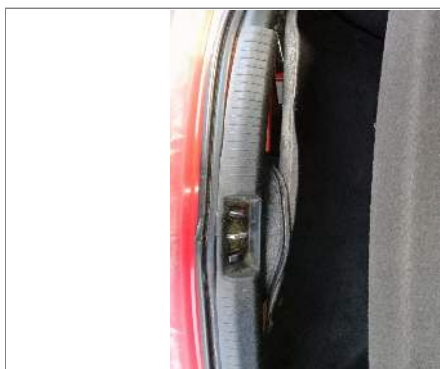
| Damage | Repair Way |
|---|---|
| Interior | Boot lock plastic cover damaged |

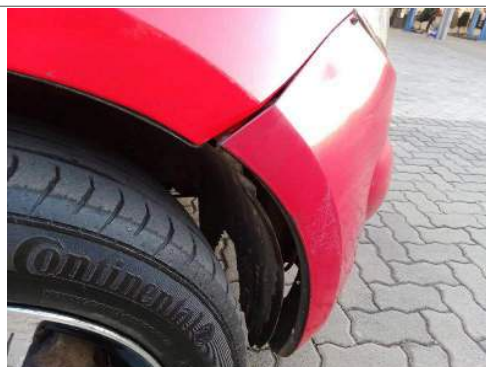
| Damage | Repair Way |
|---|---|
| Front Fender Right / Inner Tray Defective | Replace |

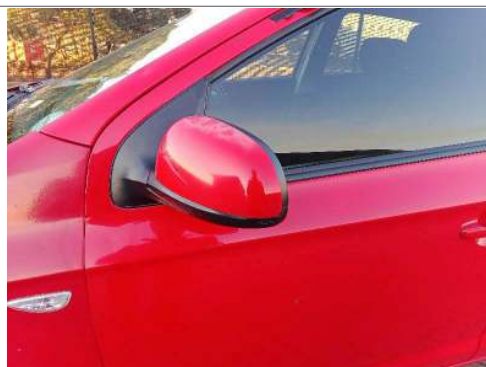
| Damage | Repair Way |
|---|---|
| Side Mirror Left Paintwork • Scratched | Repair |

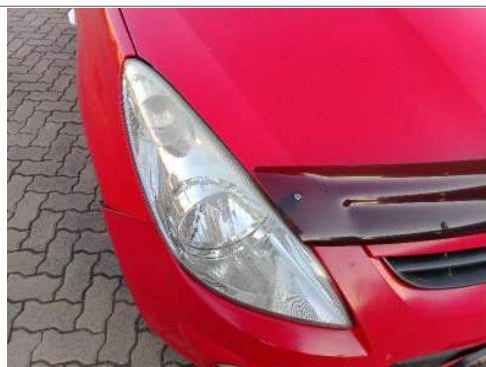
| Damage | Repair Way |
|---|---|
| Headlight Right Defective | Repair |

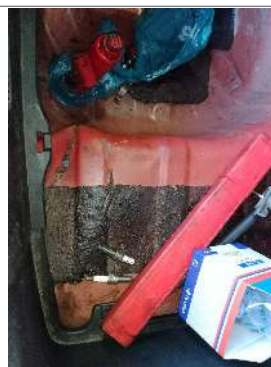
| Damage | Repair Way |
|---|---|
| Inner Boot Floor Pan and Spare Wheel Well Damaged | Repair |

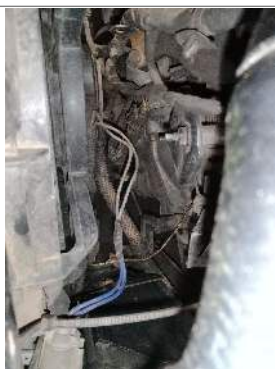
| Damage | Repair Way |
|---|---|
| Engine Wiring Defective | Repair |

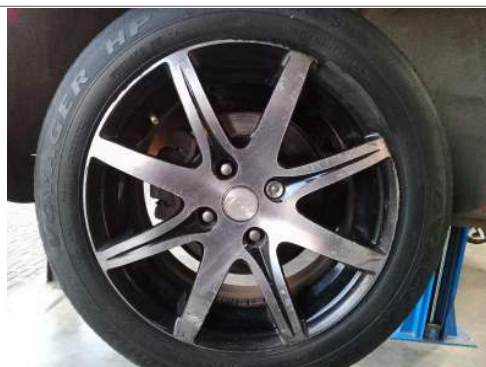
| Damage | Repair Way |
|---|---|
| Rim Rear Right Damaged | Replace |

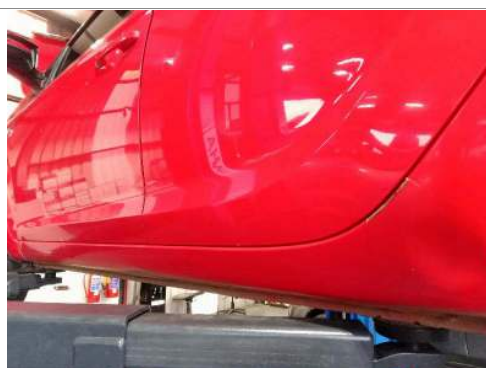
| Damage | Repair Way |
|---|---|
| Sill Panel Left Damaged | Repair |

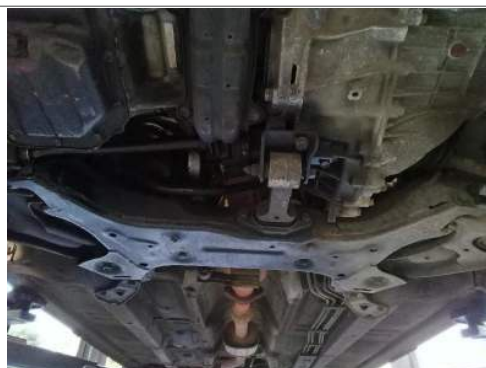
| Damage | Repair Way |
|---|---|
| Sub Frame Dented | Repair |

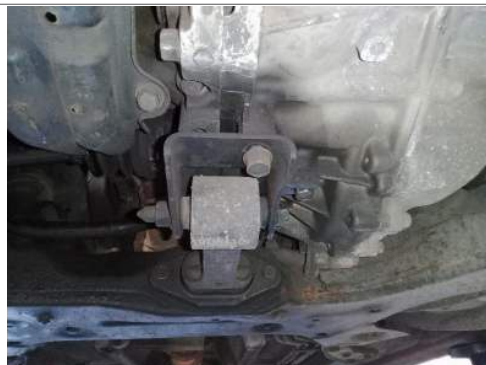
| Damage | Repair Way |
|---|---|
| Gearbox Mountings Loose / Excessive Play | Repair |

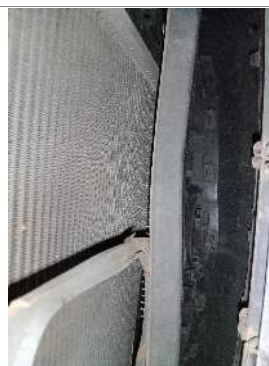
| Damage | Repair Way |
|---|---|
| Front Bumper Damaged | Repair |

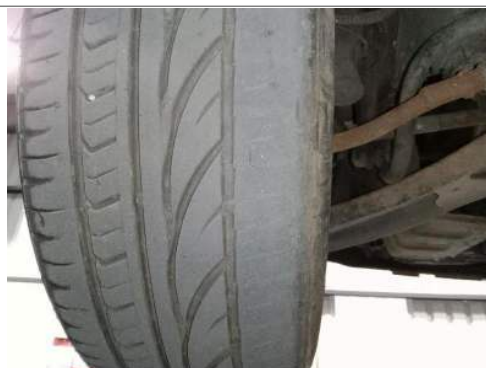
| Damage | Repair Way |
|---|---|
| Tyre Front Left Worn | Replace |

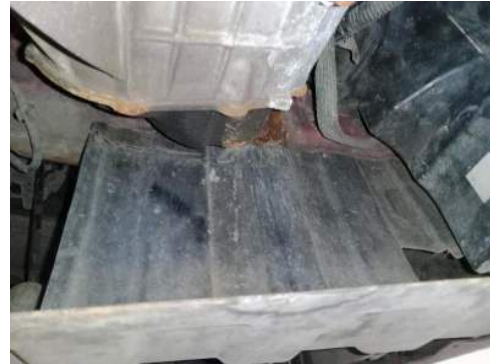
| Damage | Repair Way |
|---|---|
| Belly plates Damaged | Repair |

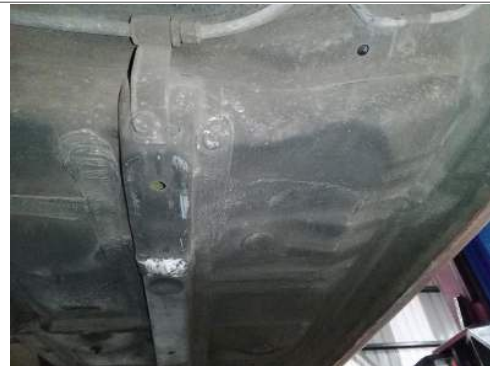
| Damage | Repair Way |
|---|---|
| Chassis Damaged | Repair |

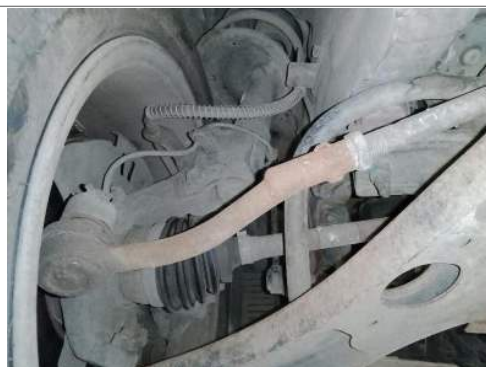
| Damage | Repair Way |
|---|---|
| Tie Rod left Defective | Replace |
