## CONDITION REPORT

Report No:  
2017302467  
DATE  
25/09/2026

MFC Auction House  
M57 Pretoria Rd, Glenmarais, KEMPTON PARK  
Gauteng

| Manufacturer | TOYOTA | Registration Number | JC11XYGP |

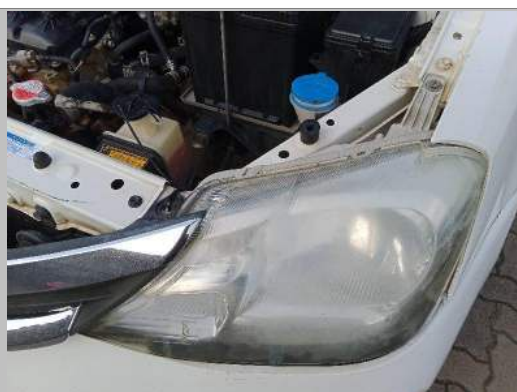
| Damage | Repair Way |
|---|---|
| Headlight Left Damaged | Replace |

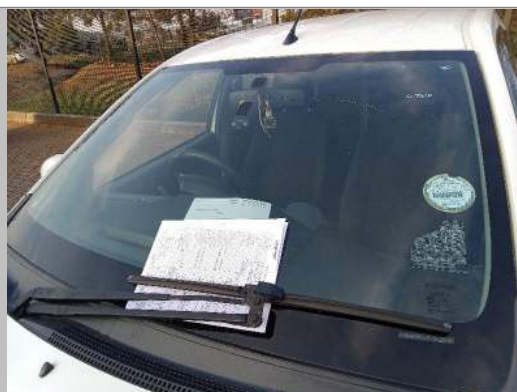
| Damage | Repair Way |
|---|---|
| Windscreen Cracked | Replace |

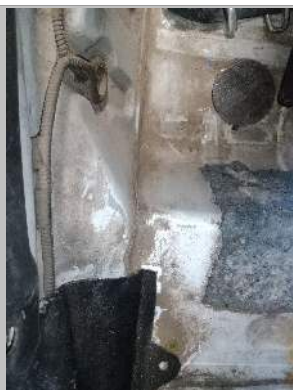
| Damage | Repair Way |
|---|---|
| Inner Boot Floor Pan and Spare Wheel Well Damaged | Repair |

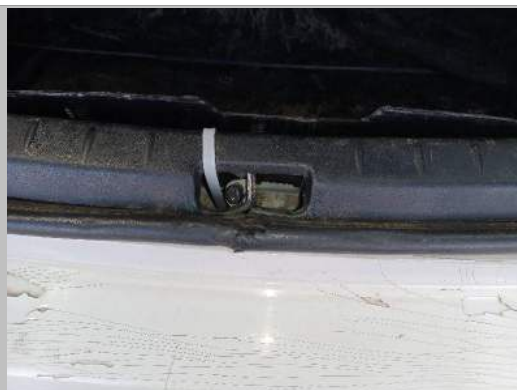
| Damage | Repair Way |
|---|---|
| Boot Lid / Hatch Door Rubbers Damaged | Replace |

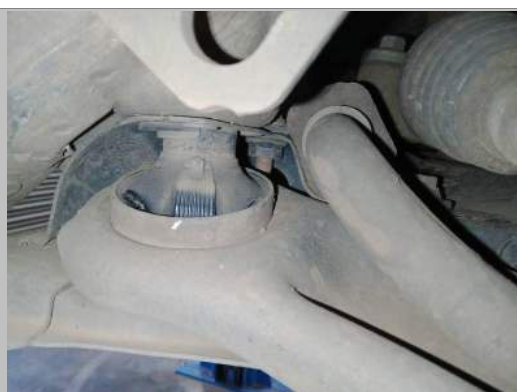
| Damage | Repair Way |
|---|---|
| Control Arm Bush(es) Front Axle Right Cracked | Replace |

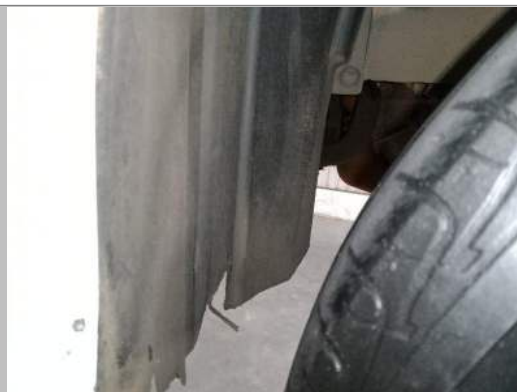
| Damage | Repair Way |
|---|---|
| Front Fender Left / Inner Tray Damaged | Replace |

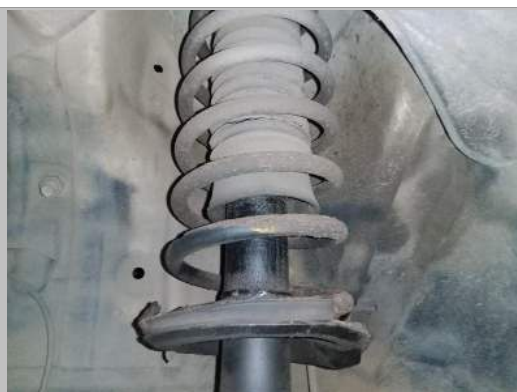
| Damage | Repair Way |
|---|---|
| Shock Absorber Front Left Leak | Replace |

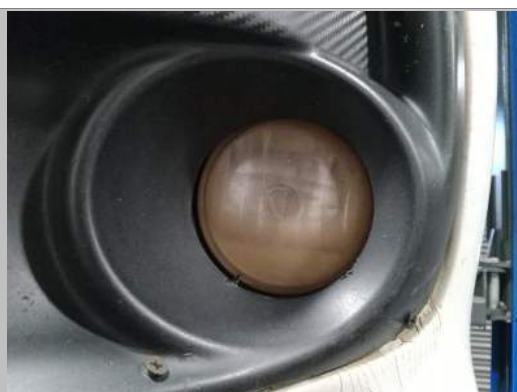
| Damage | Repair Way |
|---|---|
| Fog Light Front Left Defective | Repair |

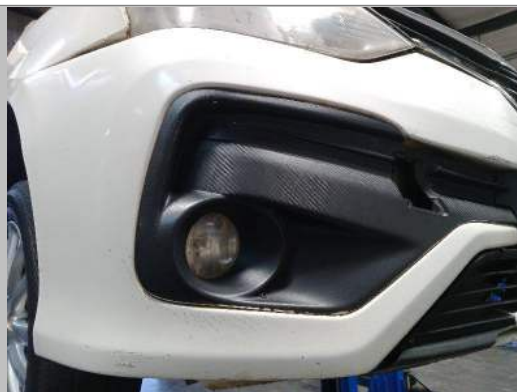
| Damage | Repair Way |
|---|---|
| Front Bumper Damaged | Replace |

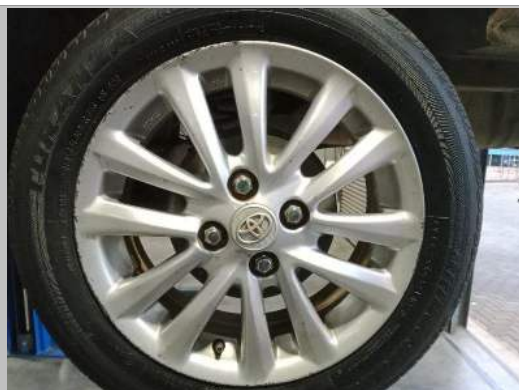
| Damage | Repair Way |
|---|---|
| Rim Rear Left Scratched | Repair |

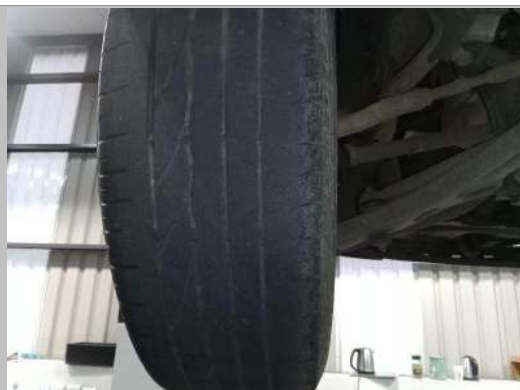
| Damage | Repair Way |
|---|---|
| Tyre Front Left Worn | Replace |

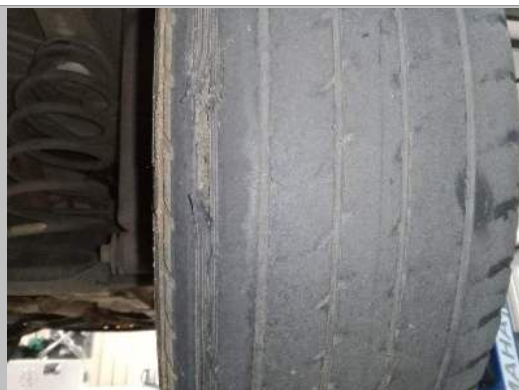
| Damage | Repair Way |
|---|---|
| Tyre Rear Right Damaged | Replace |

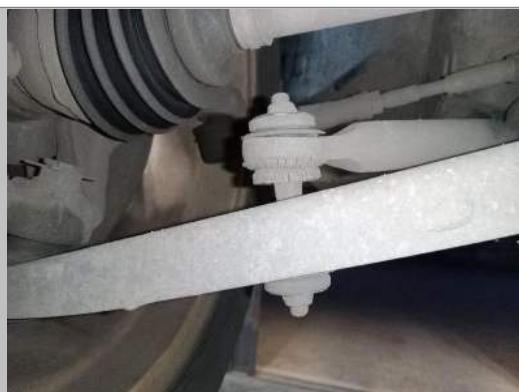
| Damage | Repair Way |
|---|---|
| Shock Absorber Mounting Front Right Damaged | Replace |

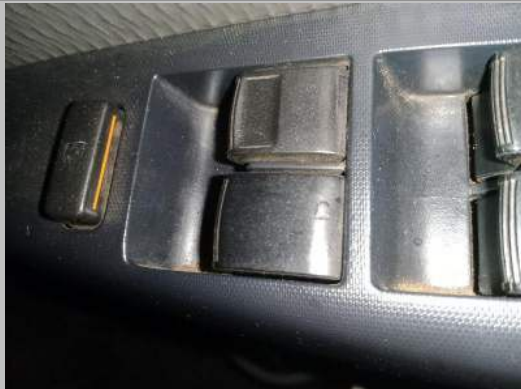
| Damage | Repair Way |
|---|---|
| Switch Electrical Window Winder front left Malfunction | Replace |
