## CONDITION REPORT

Report No:  
2017305818  
DATE  
01/10/2026

| Manufacturer | RENAULT | Registration Number | HV72GGGP |
| Model | KWID | Register Number | |

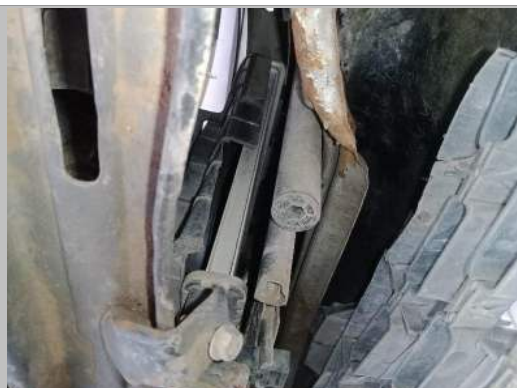
| Front bumper stiffener damaged | Replace |

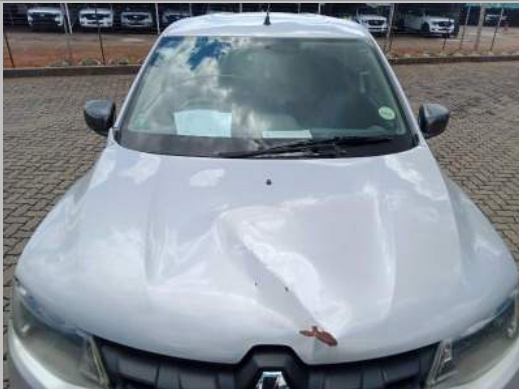
| Damage | Repair Way |
|---|---|
| Bonnet Damaged | Repair |

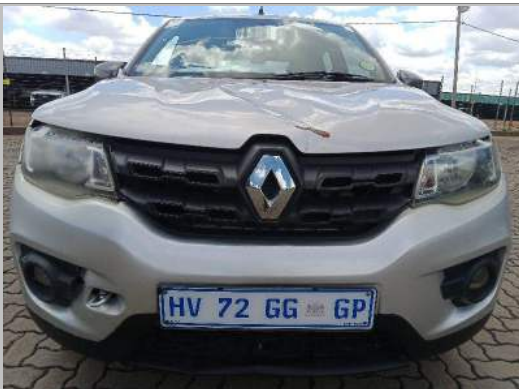
| Damage | Repair Way |
|---|---|
| Front Bumper Damaged | Replace |

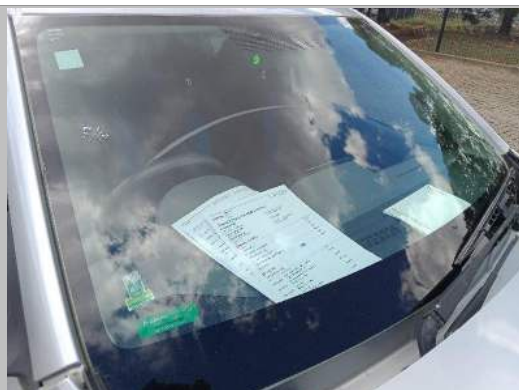
| Damage | Repair Way |
|---|---|
| Windscreen Scratched | Repair |

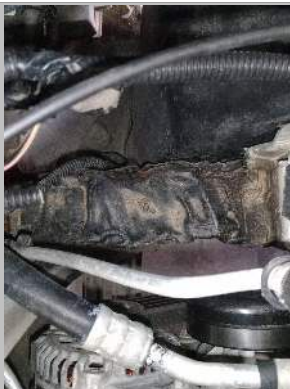
| Damage | Repair Way |
|---|---|
| Main Beam Right Damaged | Repair |

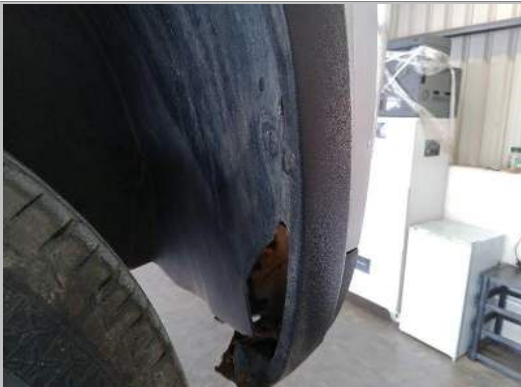
| Damage | Repair Way |
|---|---|
| Front Fender Right / Inner Tray Damaged | Replace |

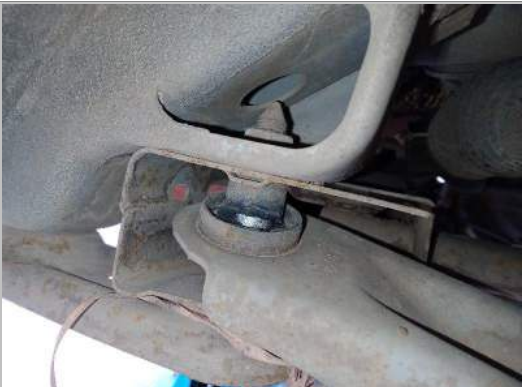
| Damage | Repair Way |
|---|---|
| Control Arm Bush(es) Front Axle Right Cracked | Replace |

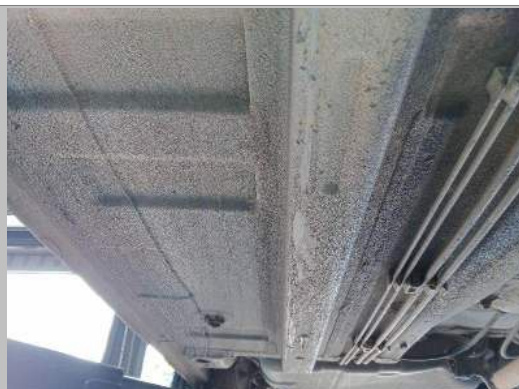
| Damage | Repair Way |
|---|---|
| Chassis Scratched | Repair |

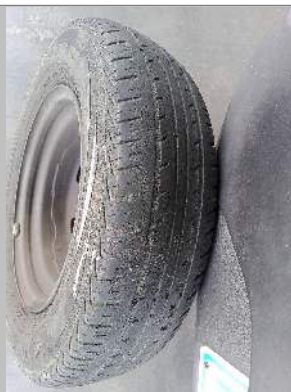
| Damage | Repair Way |
|---|---|
| Spare Tyre Damaged | Replace |

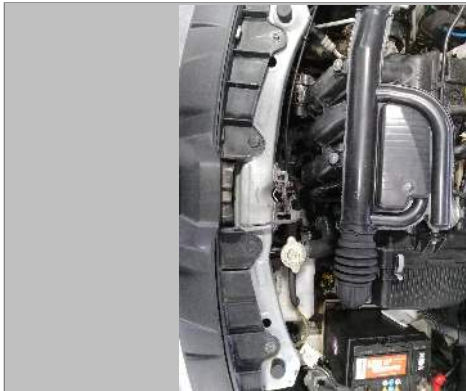
| Damage | Repair Way |
|---|---|
| Bonnet slam plate (Shock tower/ Inner tray) Damaged | Repair |
