## CONDITION REPORT

Report No:  
2017295668  
DATE  
09/09/2026

| Manufacturer | RENAULT | Registration Number | JJ82KMGP |
| Model | KWID 1.0 DYNAMIQUE 5-DR [2016-2019] | Register Number | |

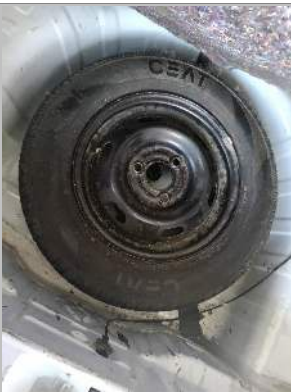
Sparewheel

| | Size | Load/Speed Index | Manufacture | Model | Type* | Production Date | Tread Depth (mm) |
|---|---|---|---|---|---|---|---|
| Spare | 155/80R13 | 79T | Ceat | Milaze | V | 0000 | 1 mm |

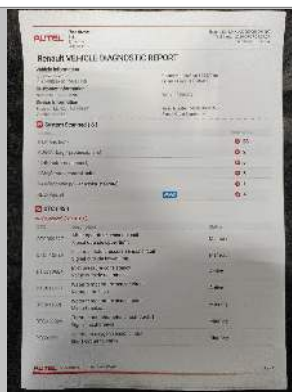
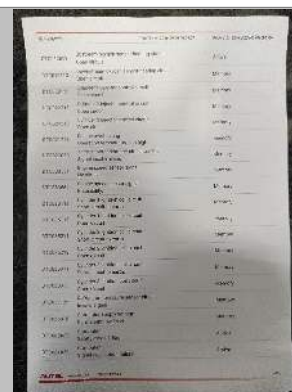
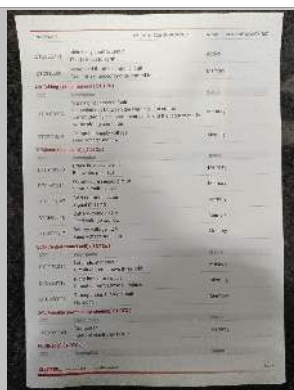
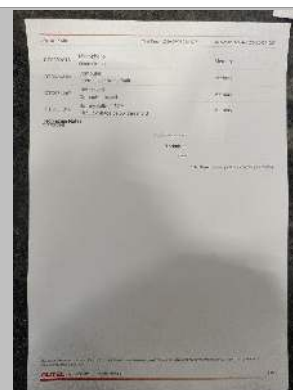
| No | System | Code | Description | Status |
|---|---|---|---|---|
| 1 | INJECTION | DTC065711 | MAIN RELAY CONTROL CIRCUIT SHORT CIRCUIT TO EARTH | |

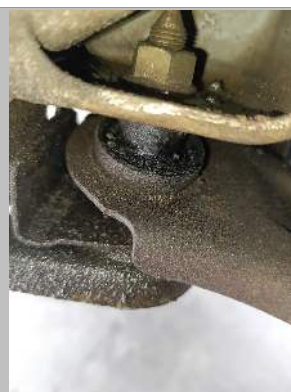
| Control Arm Bush(es) Front Axle Right Cracked | Replace |

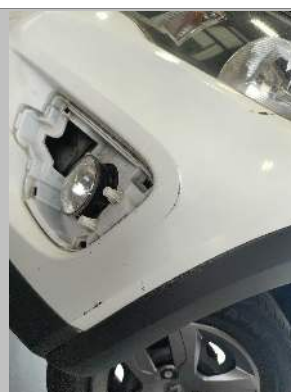
| Front Bumper Cracked | Replace |

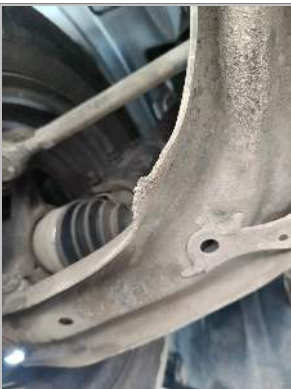
| Control Arm(s) Front Axle Left Deformed | Repair |

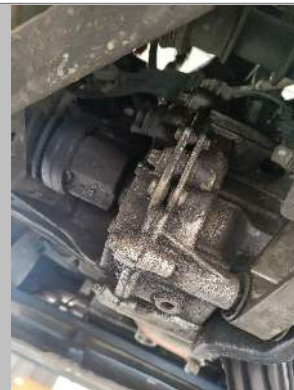
| Gearbox Oil Sweat | Repair |

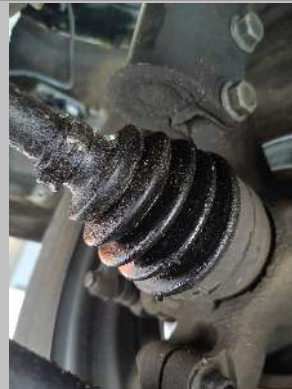
| CV Joint(s) Boot(s) Front Right (inner/outer) Damaged | Replace |

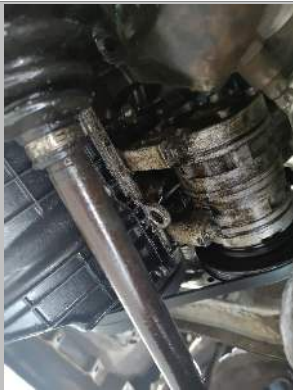
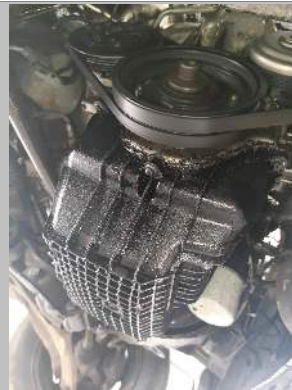
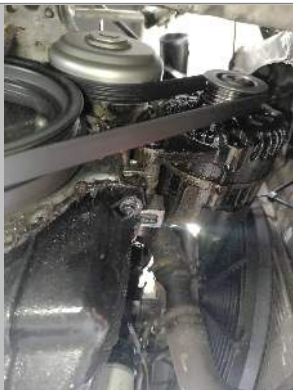
| Engine Oil Leak | Repair |
| Engine Wiring Defective | Repair |

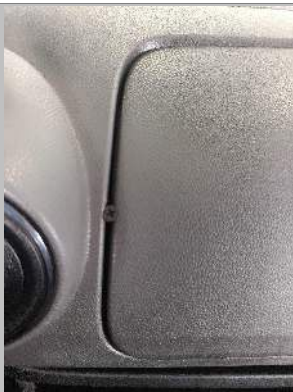
| Dash Padding Damaged | Repair |
