## CONDITION REPORT

Report No:  
2017305129  
DATE  
30/09/2026

| Manufacturer | RENAULT | Registration Number | KD30WKGP |
| Model | KWID | Register Number | |

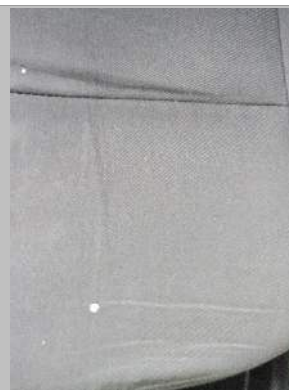
| Damage | Repair Way |
|---|---|
| Seat Front Right Damaged | Repair |

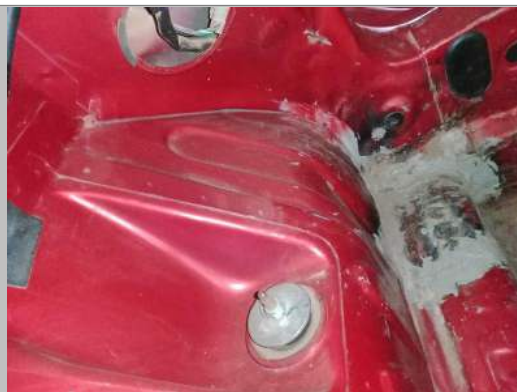
| Damage | Repair Way |
|---|---|
| Rear Fender Right / Inner Tray Damaged | Repair |

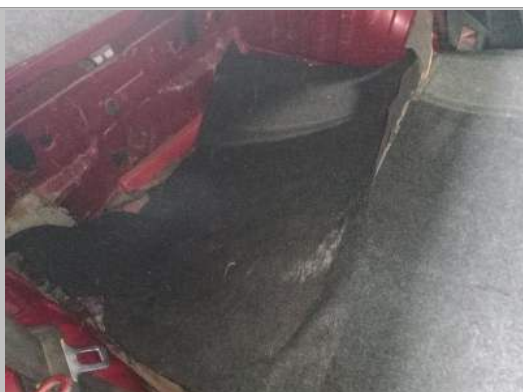
| Damage | Repair Way |
|---|---|
| Boot Carpet Damaged | Repair |

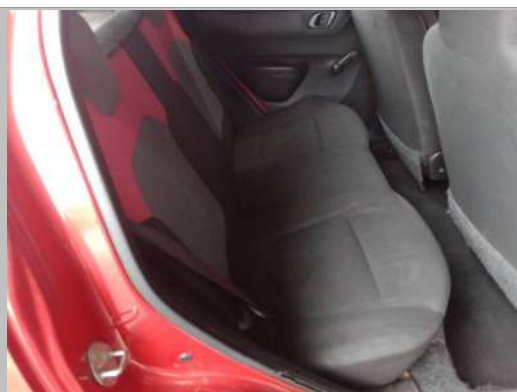
| Damage | Repair Way |
|---|---|
| Seat Rear Damaged | Repair |

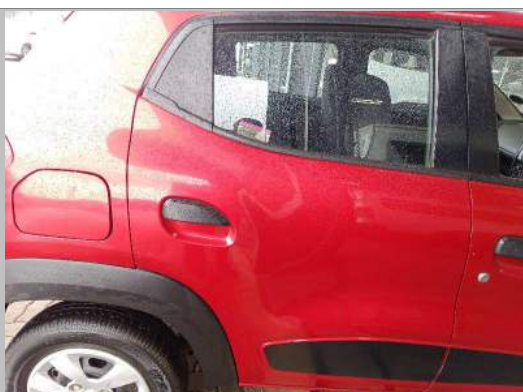
| Damage | Repair Way |
|---|---|
| Door Rear Right Dented | Repair |

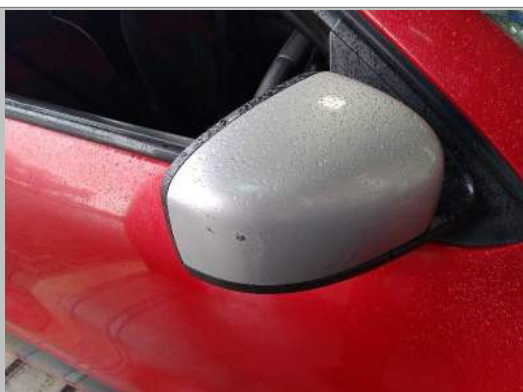
| Damage | Repair Way |
|---|---|
| Side Mirror Right Paintwork • Scratched | Repair |

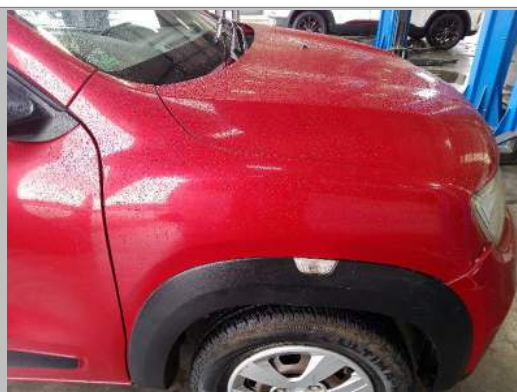
| Damage | Repair Way |
|---|---|
| Front Fender Right Damaged | Repair |

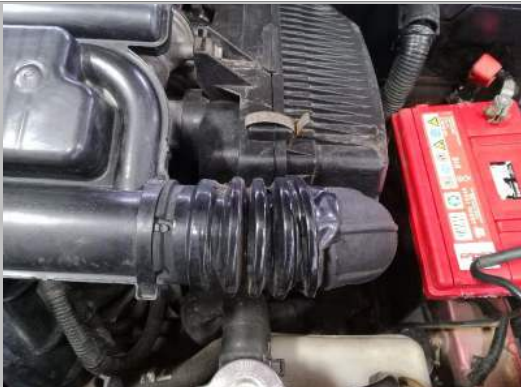
| Damage | Repair Way |
|---|---|
| Hoses Damaged | Replace |

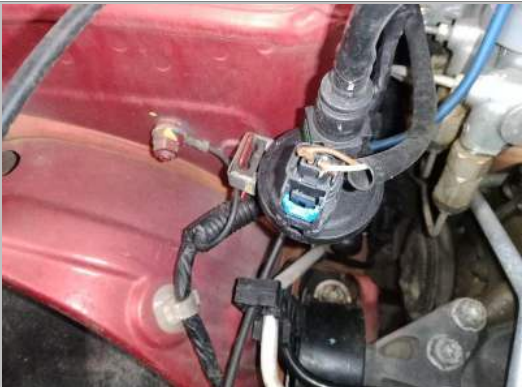
| Damage | Repair Way |
|---|---|
| Engine Wiring Defective | Replace |

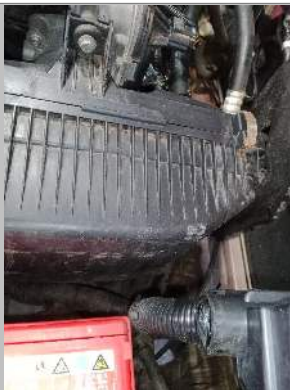
| Damage | Repair Way |
|---|---|
| Air cleaner Damaged | Repair |

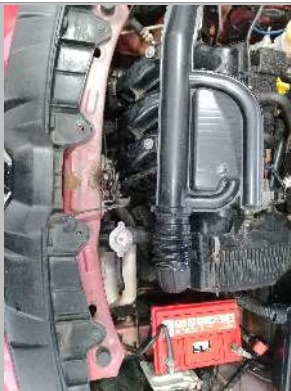
| Damage | Repair Way |
|---|---|
| Bonnet slam plate (Shock tower/ Inner tray) Damaged | Repair |

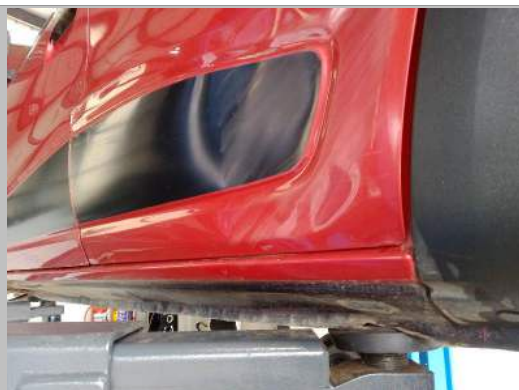
| Damage | Repair Way |
|---|---|
| Sill Panel Left Damaged | Repair |

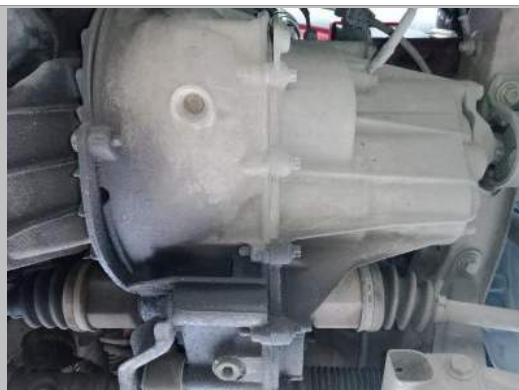
| Damage | Repair Way |
|---|---|
| Gearbox Oil Sweat | Repair |

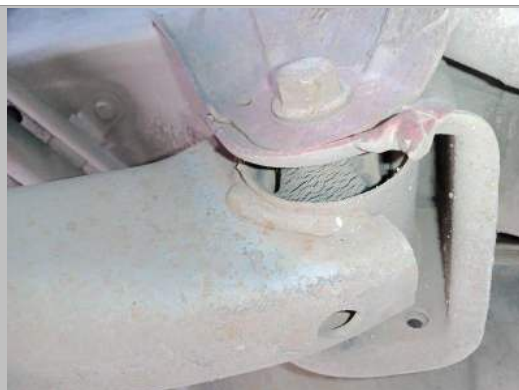
| Damage | Repair Way |
|---|---|
| Mounting Rubber(s) Rear Axle Right Cracked | Replace |
