## CONDITION REPORT

Report No:  
2017306419  
DATE  
02/10/2026

| Manufacturer | RENAULT | Registration Number | LW91TRGP |
| Model | TRIBER | Register Number | |

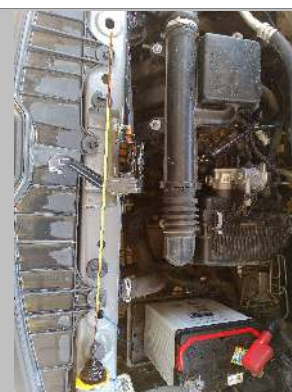
Oil cap and dipstick

| Damage | Repair Way |
|---|---|
| Oil sludge on oil cap | Repair |

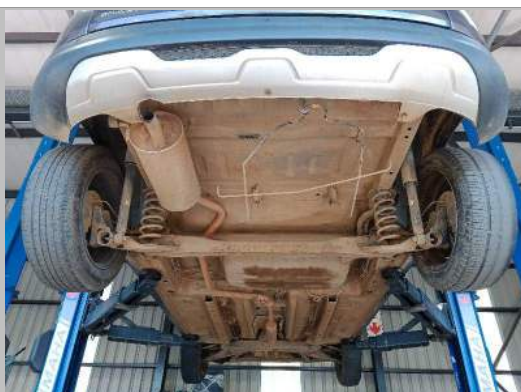
Rear chassis

| Damage | Repair Way |
|---|---|
| Chassis Dented | Repair |

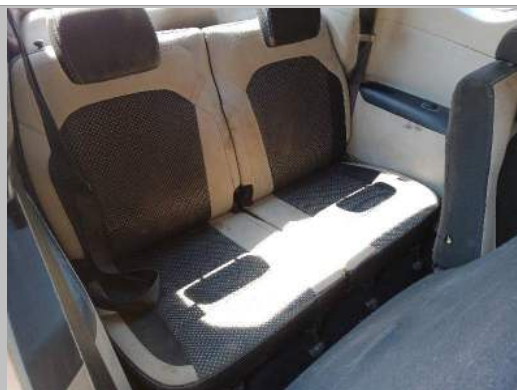
| Damage | Repair Way |
|---|---|
| Seat Rear ( 2. Row) Damaged | Repair |

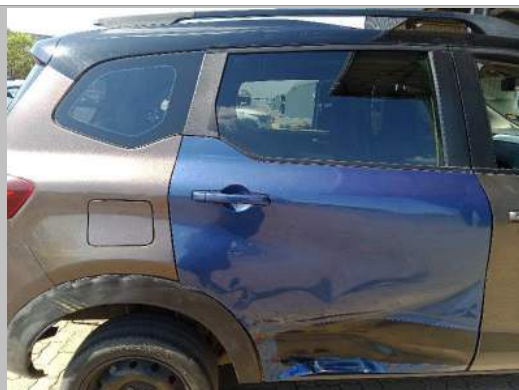
| Damage | Repair Way |
|---|---|
| Door Rear Right Damaged | Repair |

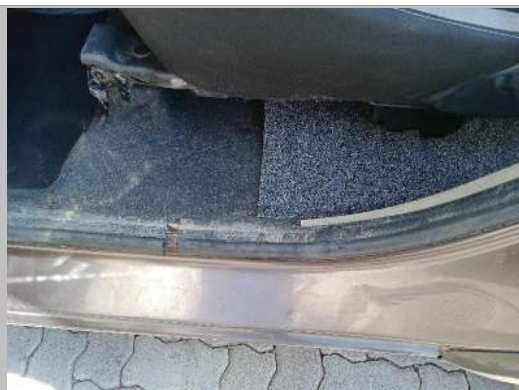
| Damage | Repair Way |
|---|---|
| Door Sealing Rubber Rear Left Damaged | Replace |

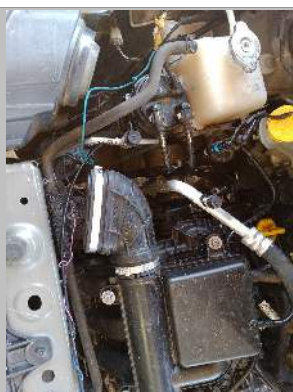
| Damage | Repair Way |
|---|---|
| Engine Wiring Defective | Repair |

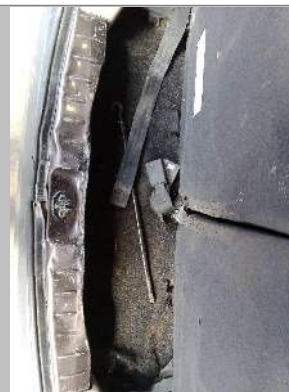
| Damage | Repair Way |
|---|---|
| Inner Boot Floor Pan and Spare Wheel Well Damaged | Repair |

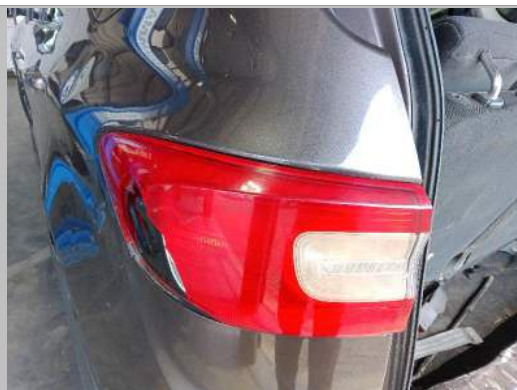
| Damage | Repair Way |
|---|---|
| Tail Light Left Damaged | Replace |

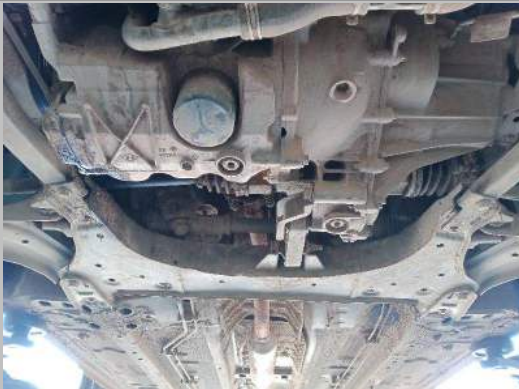
| Damage | Repair Way |
|---|---|
| Sub Frame Damaged | Repair |

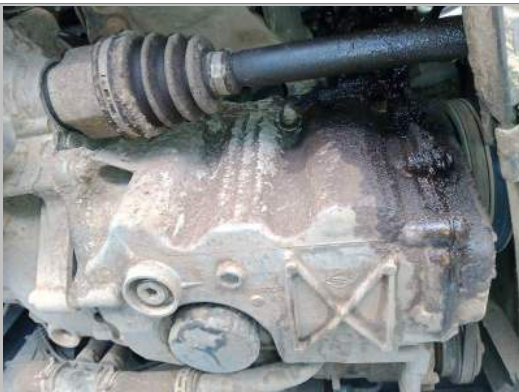
| Damage | Repair Way |
|---|---|
| Engine Oil Leak | Repair |
| Engine Noise Excessive | Repair |

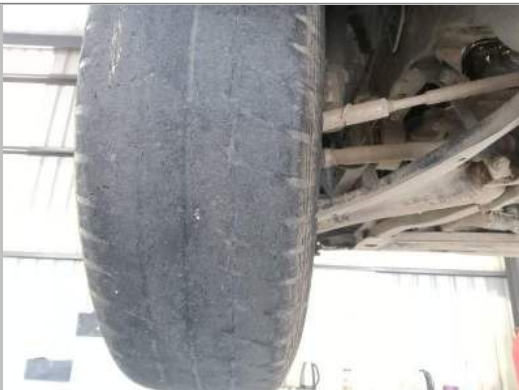
| Damage | Repair Way |
|---|---|
| Tyre Front Left Damaged | Replace |
