## CONDITION REPORT

Report No:  
2017294297  
DATE  
04/09/2026

| Manufacturer | NISSAN | Registration Number | JZP592EC |
| Model | NAVARA 2.3 LE D-CAB DSL 4X4 PU [2017-2019] | Register Number | |

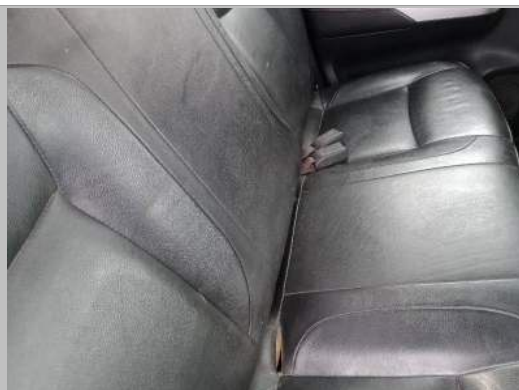
| Damage | Repair Way |
|---|---|
| Seat Belt Rear Middle Missing | Replace |

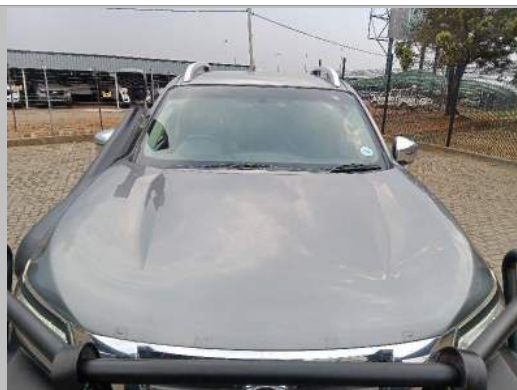
| Damage | Repair Way |
|---|---|
| Bonnet Damaged | Repair |

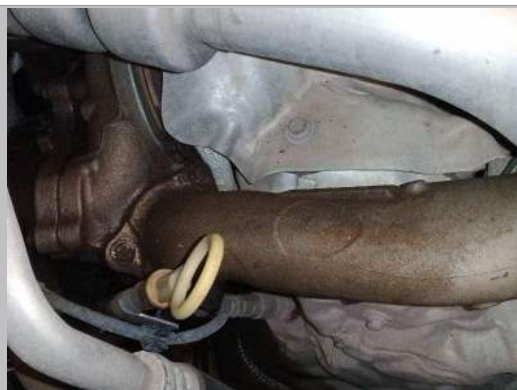
| Damage | Repair Way |
|---|---|
| Hoses Oil Leak | Replace |

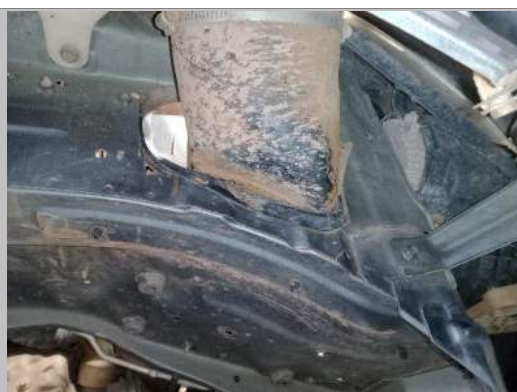
| Damage | Repair Way |
|---|---|
| Front Fender Right / Inner Tray Damaged | Repair |

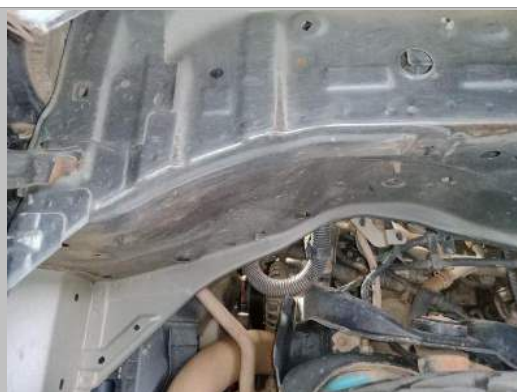
| Damage | Repair Way |
|---|---|
| Front Fender Left / Inner Tray Paintwork • Scratched | Smart Repair |

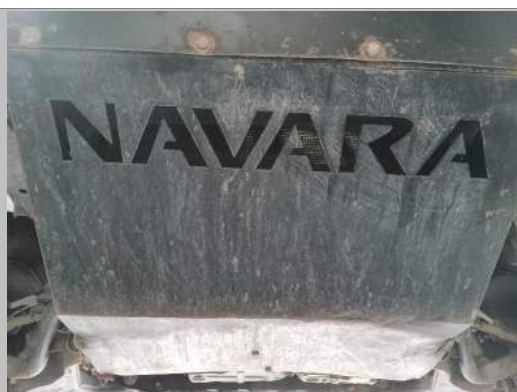
| Damage | Repair Way |
|---|---|
| Belly plates Damaged | Repair |

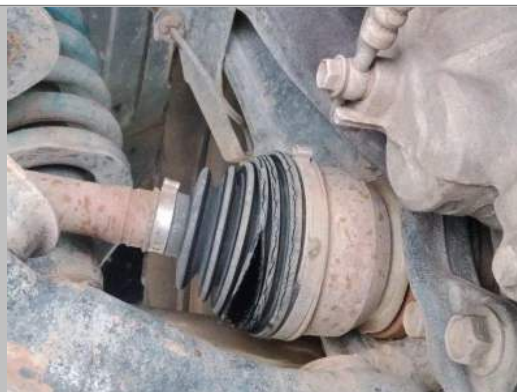
| Damage | Repair Way |
|---|---|
| CV Joint(s) Boot(s) Front Right (inner/outer) Damaged | Replace |

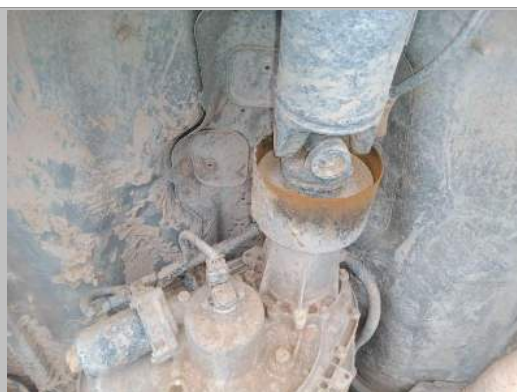
| Damage | Repair Way |
|---|---|
| Gearbox Oil Sweat | Repair |
