## CONDITION REPORT

Report No:  
2017304158  
DATE  
28/09/2026

MFC Auction House  
M57 Pretoria Rd, Glenmarais, KEMPTON PARK  
Gauteng

| Manufacturer | PEUGEOT | Registration Number | DF51LBGP |

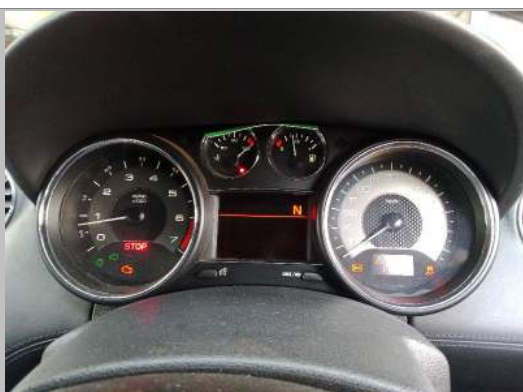
DASHBOARD (W/ ENGINE RUNNING)

| Damage | Repair Way |
|---|---|
| Warning lights illuminated on dashboard | Repair |

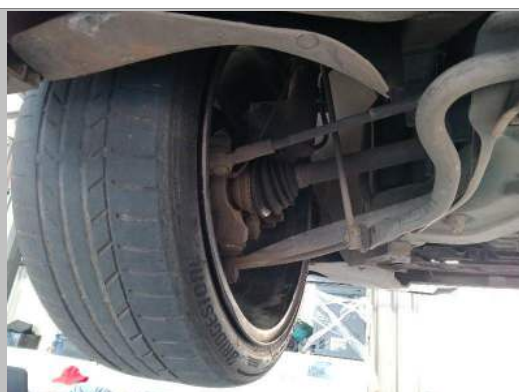
LF TYRE TREAD

| Damage | Repair Way |
|---|---|
| Tyre Front Left Damaged | Replace |
| Front left and right tyres regrooved | Replace |

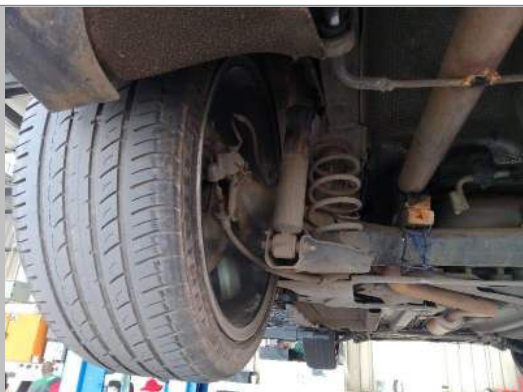
LR TYRE TREAD

| Damage | Repair Way |
|---|---|
| Tyre Rear Left Worn | Replace |

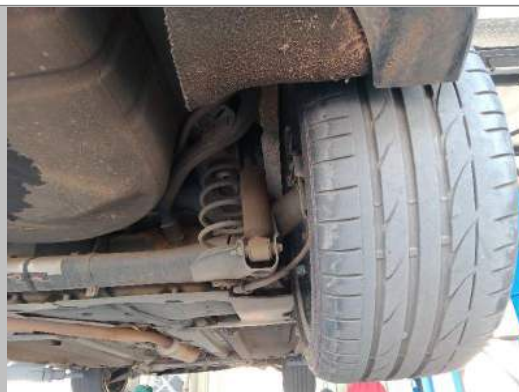
RR TYRE TREAD

| Damage | Repair Way |
|---|---|
| Tyre Rear Right Damaged | Replace |

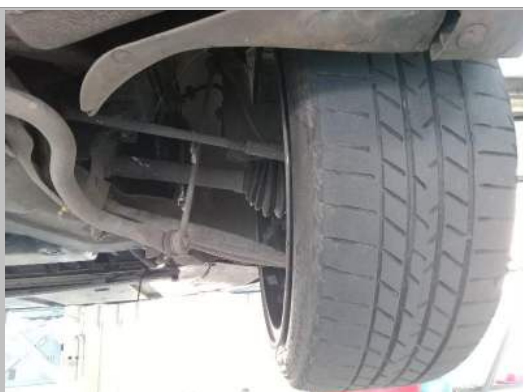
RF TYRE TREAD

| Damage | Repair Way |
|---|---|
| Tyre Front Right Damaged | Replace |

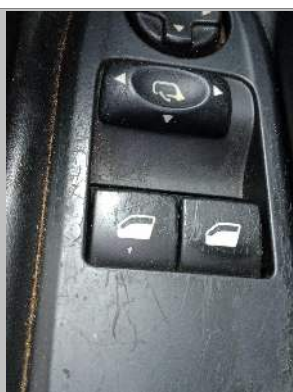
| Damage | Repair Way |
|---|---|
| Switch Electrical Window Winder front left Malfunction | Replace |

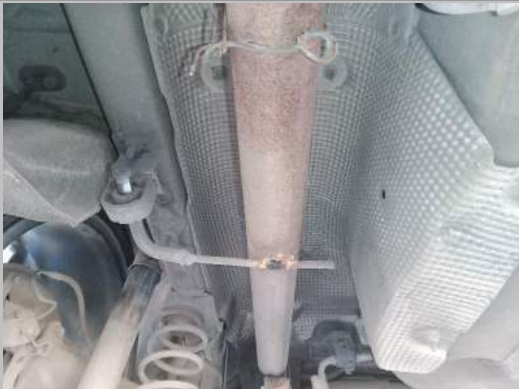
| Damage | Repair Way |
|---|---|
| Silencer Missing | Replace |
