## CONDITION REPORT

Report No:  
2016957012  
DATE  
24/07/2025

| Manufacturer | AUDI | Registration Number | DV39TLGP |
| Model | A3 SPORTBACK 1.4T FSI S 5-DR [2014-2017] | Register Number | |

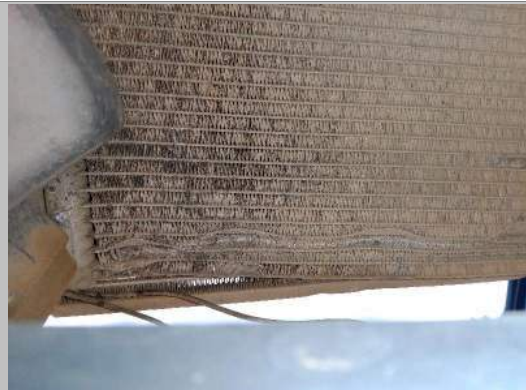
| Damage | Repair Way |
|---|---|
| Engine | Aircon condenser damaged |

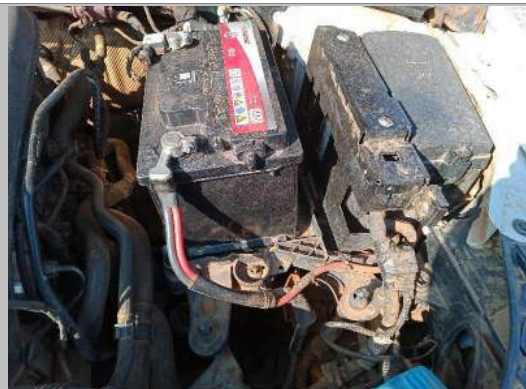
| Damage | Repair Way |
|---|---|
| Battery box Damaged | Replace |

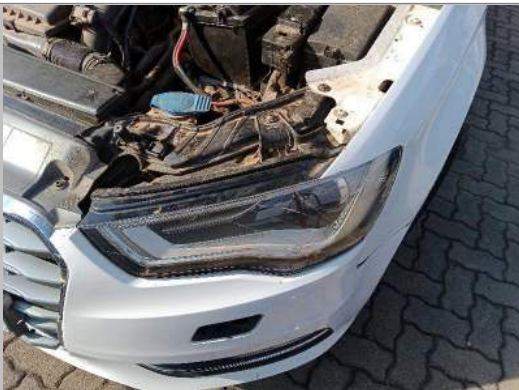
| Damage | Repair Way |
|---|---|
| Headlight Left Damaged | Replace |

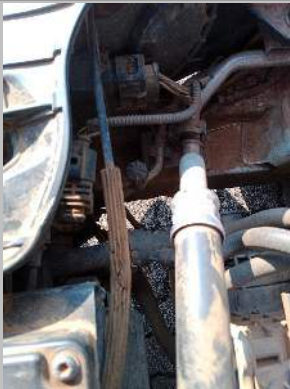
| Damage | Repair Way |
|---|---|
| Bonnet cable Defective | Repair |

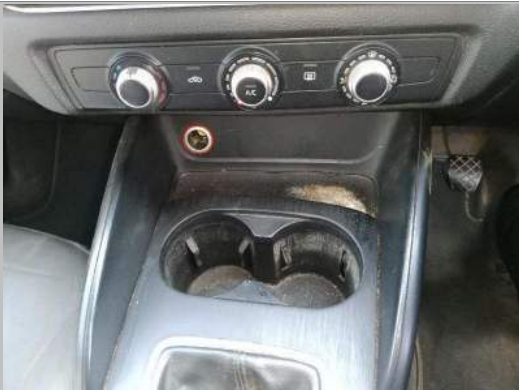
| Damage | Repair Way |
|---|---|
| Center Console / Cubbyhole + Lid Defective | Repair |

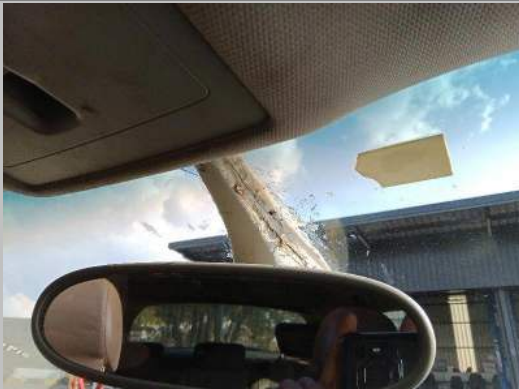
| Damage | Repair Way |
|---|---|
| Interior Mirror Damaged | Replace |

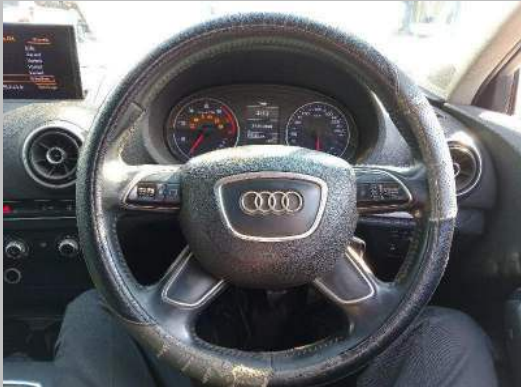
| Damage | Repair Way |
|---|---|
| Steering Wheel Trim Defective | Repair |

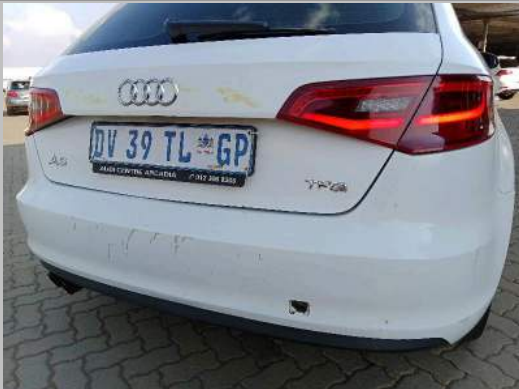
| Damage | Repair Way |
|---|---|
| Rear bumper Damaged | Repair |

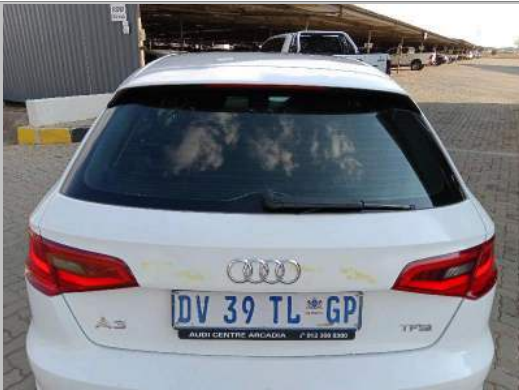
| Damage | Repair Way |
|---|---|
| Boot Lid / Hatch door Damaged | Repair |

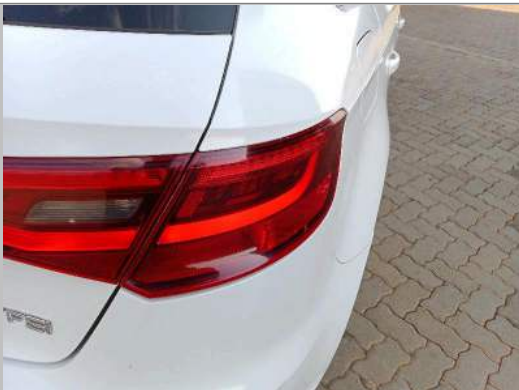
| Damage | Repair Way |
|---|---|
| Tail Light Right Broken | Replace |

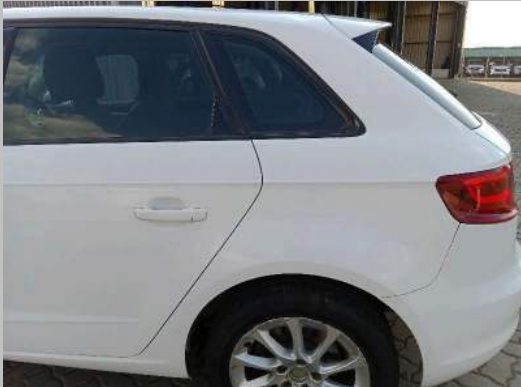
| Damage | Repair Way |
|---|---|
| Rear Fender Left Residual Traces of Repair | Repair |

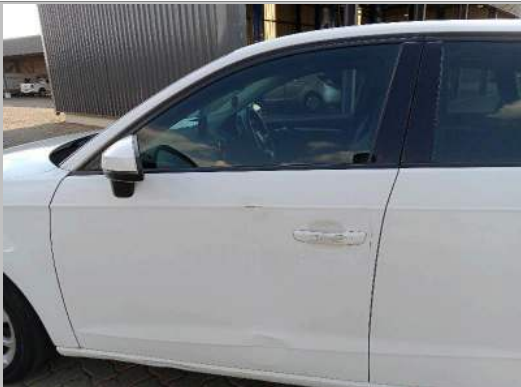
| Damage | Repair Way |
|---|---|
| Door Front Left Damaged | Repair |

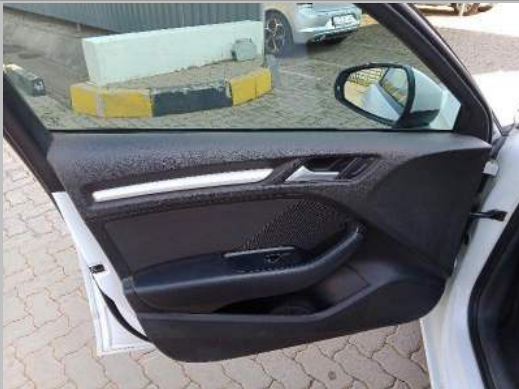
| Damage | Repair Way |
|---|---|
| Door Panel Front Left Defective | Repair |

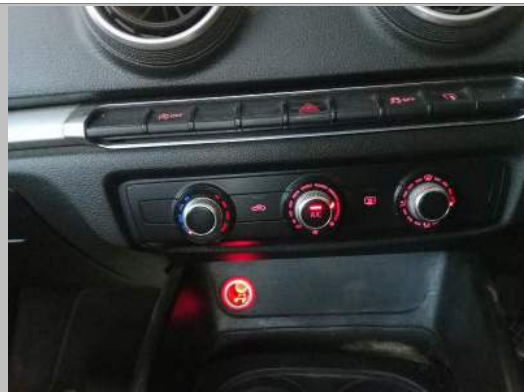
| Damage | Repair Way |
|---|---|
| Air Conditioner Malfunction | Repair |

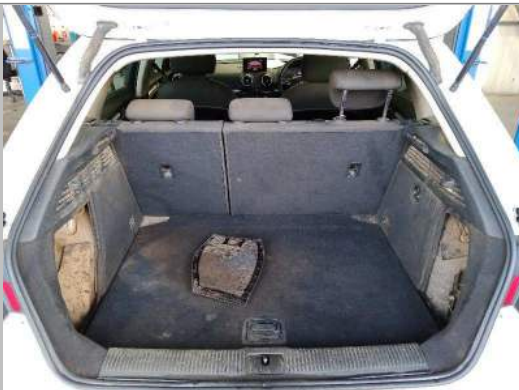
| Damage | Repair Way |
|---|---|
| Parcel Tray Missing | Replace |

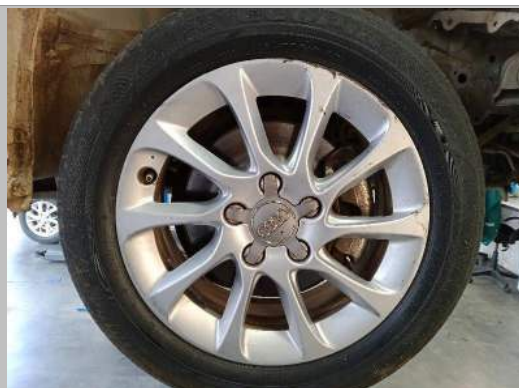
| Damage | Repair Way |
|---|---|
| Rim Front Right Scratched | Repair |

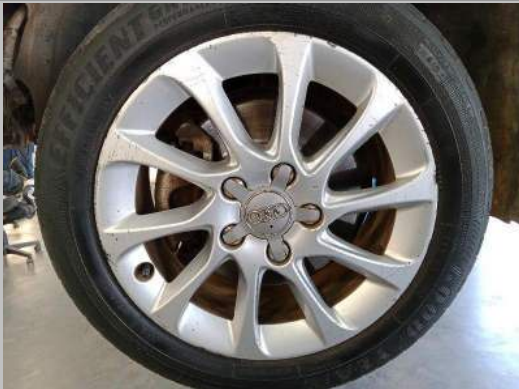
| Damage | Repair Way |
|---|---|
| Rim Front Left Scratched | Repair |

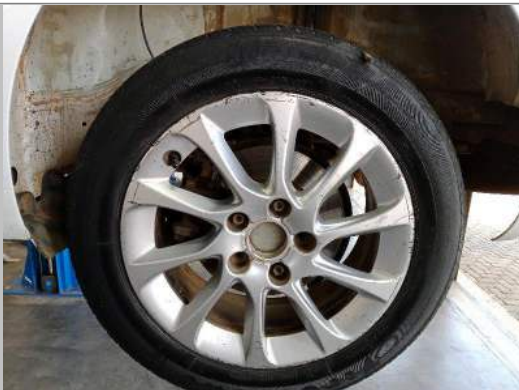
| Damage | Repair Way |
|---|---|
| Bolt(s) / Nut(s) Rear Wheel Left Missing | Replace |

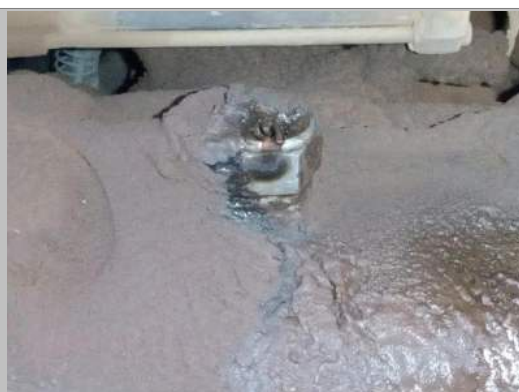
| Damage | Repair Way |
|---|---|
| Engine Oil Leak | Repair |

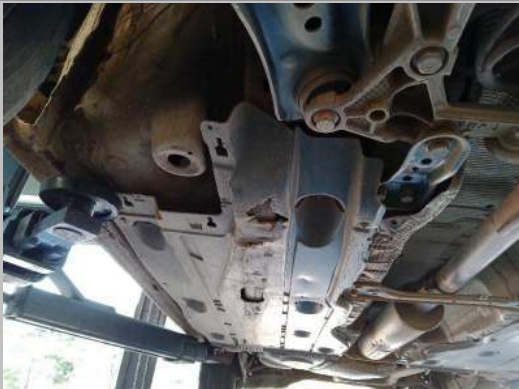
| Damage | Repair Way |
|---|---|
| Sub Frame Dented | Repair |

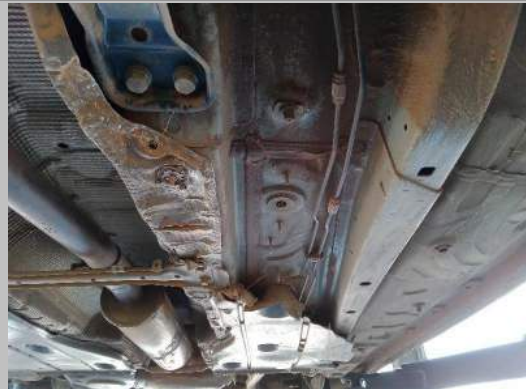
| Damage | Repair Way |
|---|---|
| Belly plates Damaged | Repair |

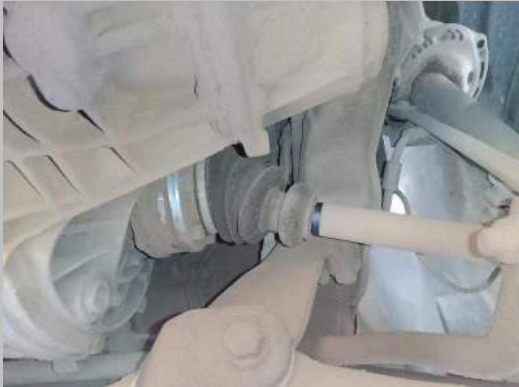
| Damage | Repair Way |
|---|---|
| Stabilizer Mounting Front Right Damaged | Replace |

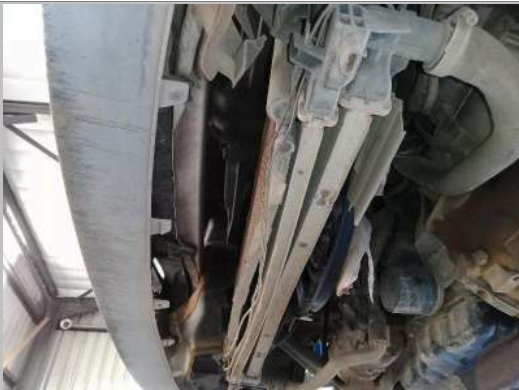
| Damage | Repair Way |
|---|---|
| Radiator Cradle Damaged | Replace |

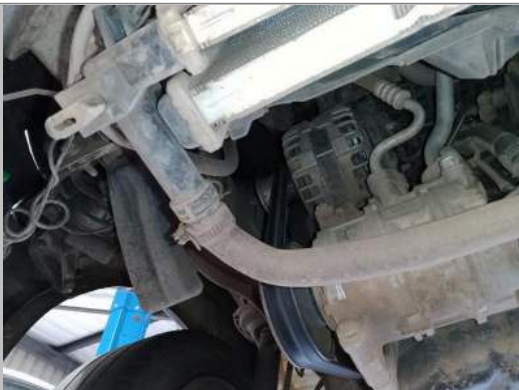
| Damage | Repair Way |
|---|---|
| Engine | Fan Cowley damaged |

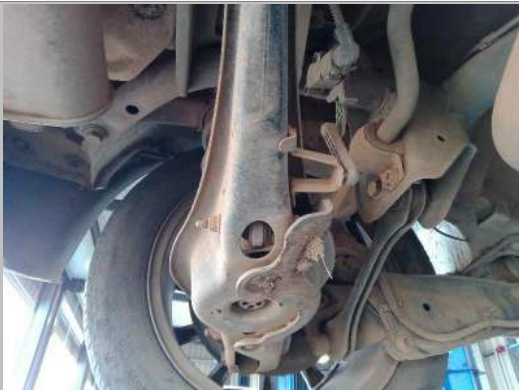
| Damage | Repair Way |
|---|---|
| Brake Piping Leak | Replace |

| Damage | Repair Way |
|---|---|
| Brakes | Rear left brake piping leaking |
