## CONDITION REPORT

Report No: 2016866839

| Manufacturer | FORD | Registration Number | JB40BLGP |
| Model | KUGA 2.0 ECOBOOST TITANIUM AWD AT [2014-2016] | Register Number | |

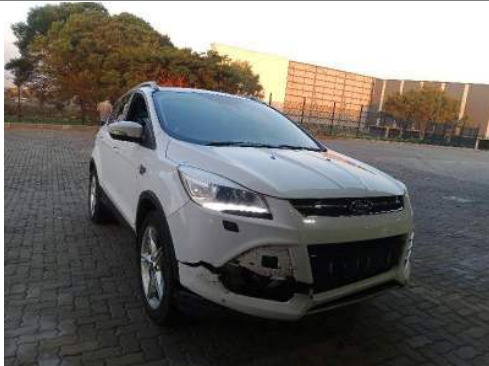
FRONT RIGHT CORNER

| Damage | Repair Way |
|---|---|
| Body and Exterior | Signs of impact damage to front of vehicle |

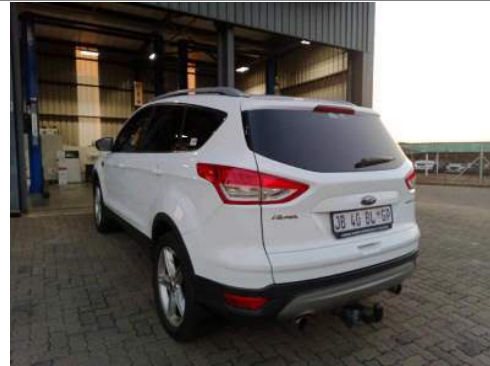
REAR LEFT CORNER

| Damage | Repair Way |
|---|---|
| Body and Exterior | Traces of repair work done on rear of vehicle. |

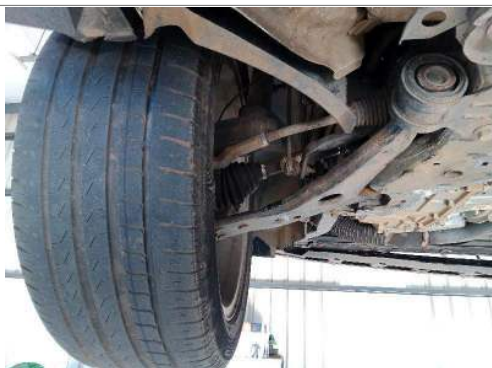
LF TYRE TREAD

| Damage | Repair Way |
|---|---|
| Tyre Front Left Damaged | Replace |

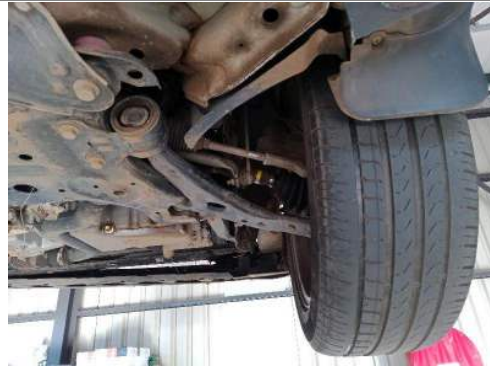
RF TYRE TREAD

| Damage | Repair Way |
|---|---|
| Tyre Front Right Damaged | Replace |

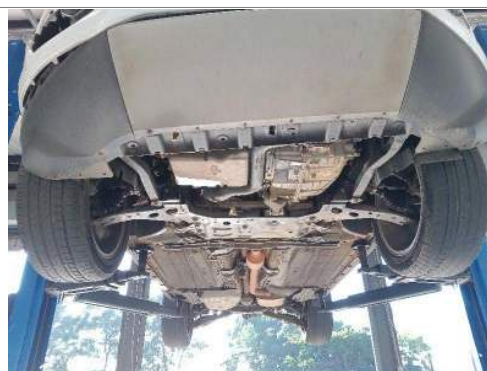
Front chassis

| Damage | Repair Way |
|---|---|
| Chassis Damaged | Repair |

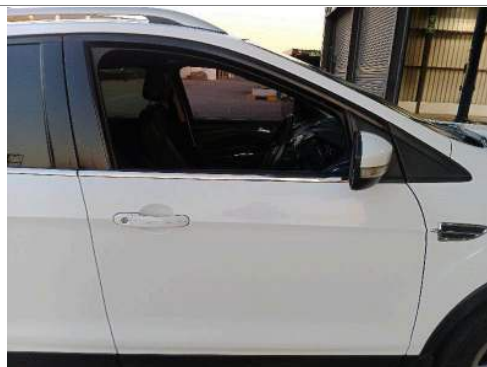
| Damage | Repair Way |
|---|---|
| Door Front Right Paintwork • Scratched | Repair |

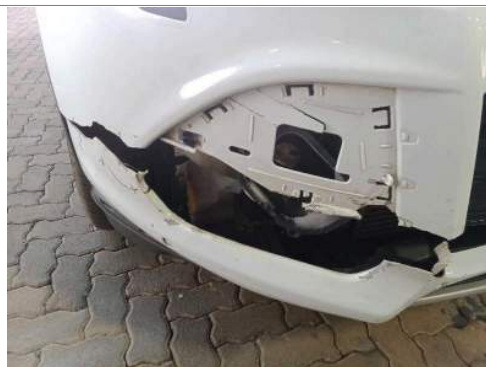
| Damage | Repair Way |
|---|---|
| Fog Light Front Right Missing | Replace |

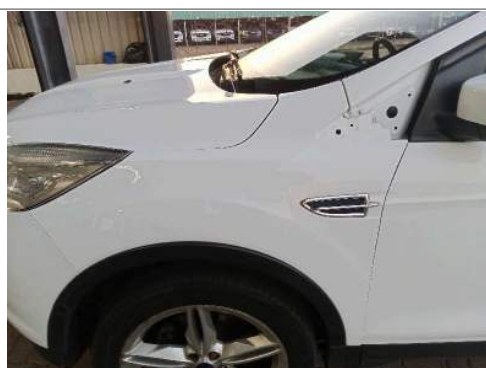
| Damage | Repair Way |
|---|---|
| Front Fender Left Dented | Repair |

| Damage | Repair Way |
|---|---|
| Front Fender Left / Inner Tray Damaged | Repair |

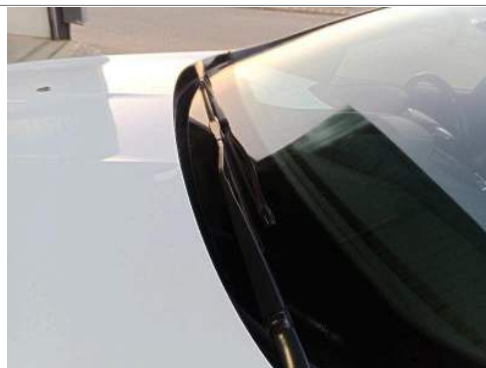
| Damage | Repair Way |
|---|---|
| Windscreen Wiper Damaged | Replace |

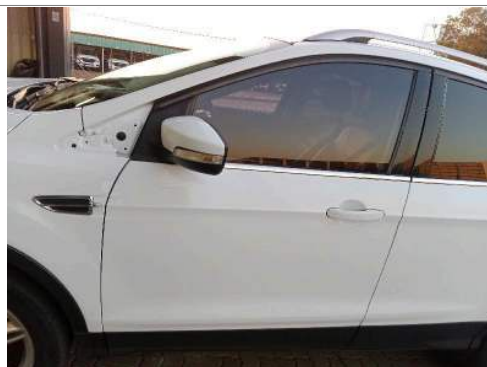
| Damage | Repair Way |
|---|---|
| Door Front Left Paintwork • Scratched | Repair |

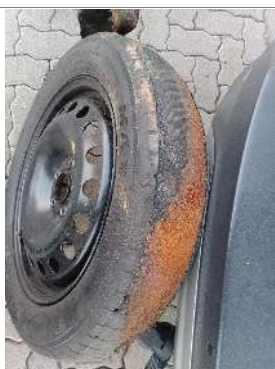
| Damage | Repair Way |
|---|---|
| Spare Tyre Damaged | Replace |
