## CONDITION REPORT

Report No: 2016824067

DATE  
02/04/2025

| Manufacturer | FORD | Registration Number | KST174MP |

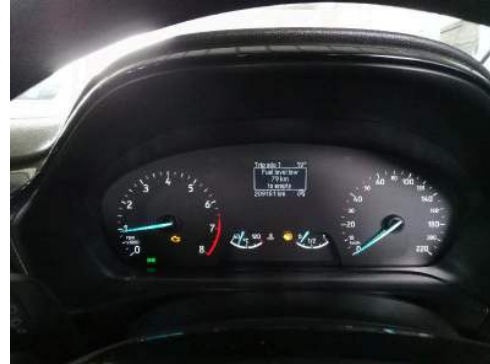
DASHBOARD (W/ ENGINE RUNNING)

| Damage | Repair Way |
|---|---|
| Warning light illuminated on dashboard | Repair |

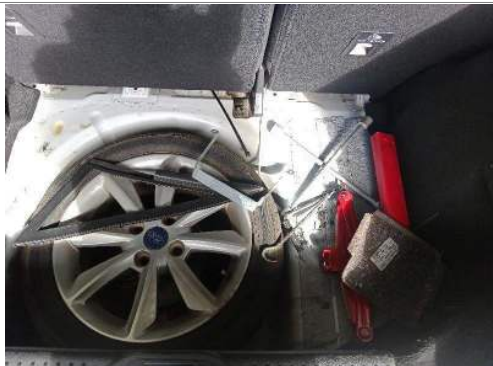
Spare wheel and Accessories

| Damage | Repair Way |
|---|---|
| Tyres and rims | Spare wheel deflated |

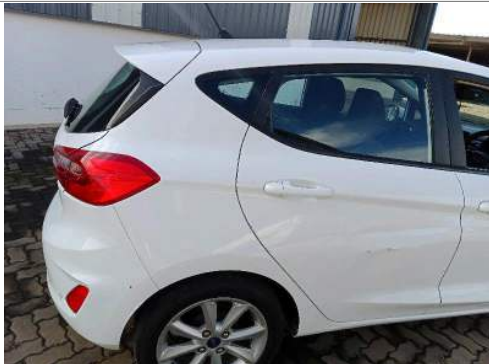
| Damage | Repair Way |
|---|---|
| Rear Fender Right Damaged | Repair |

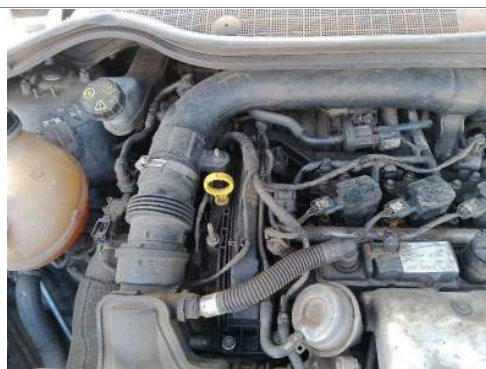
| Damage | Repair Way |
|---|---|
| Engine Oil Leak | Repair |

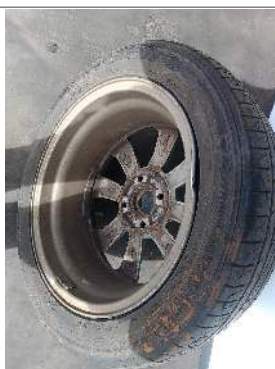
| Damage | Repair Way |
|---|---|
| Rim Spare Wheel Dented | Repair |

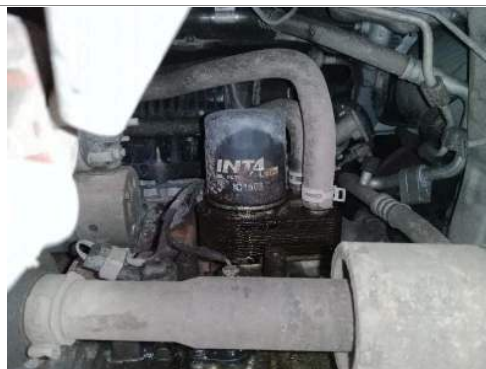
| Damage | Repair Way |
|---|---|
| Engine | Engine bay dirty. |
