## CONDITION REPORT

Report No:  
2016957999  
DATE  
25/07/2025

MFC Auction House  
M57 Pretoria Rd, Glenmarais, KEMPTON PARK  
Gauteng

| Manufacturer | FORD | Registration Number | KNX706MP |

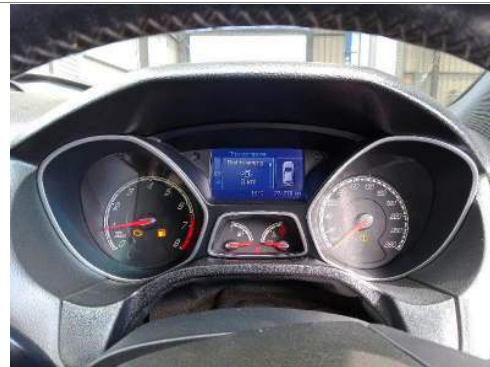
DASHBOARD (W/ ENGINE RUNNING)

| Damage | Repair Way |
|---|---|
| Warning lights illuminated on dashboard | Repair |

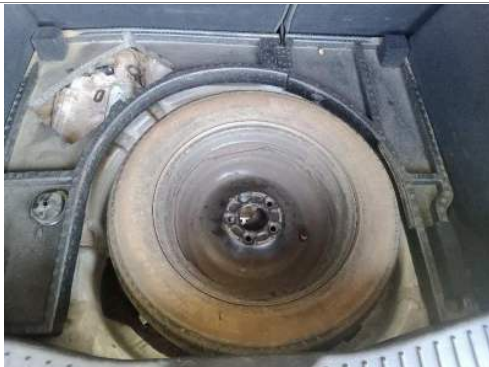
Spare wheel

| Damage | Repair Way |
|---|---|
| Spare Tyre Torn / Cut | Replace |

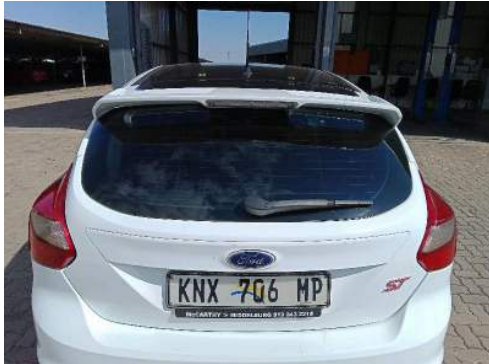
| Damage | Repair Way |
|---|---|
| Boot Lid / Hatch door Paintwork • Scratched | Repair |

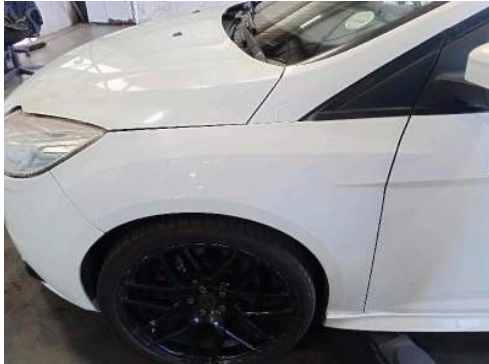
| Damage | Repair Way |
|---|---|
| Front Fender Left Damaged | Repair |

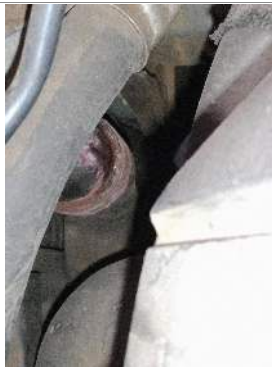
| Damage | Repair Way |
|---|---|
| Hoses Water Leak | Replace |

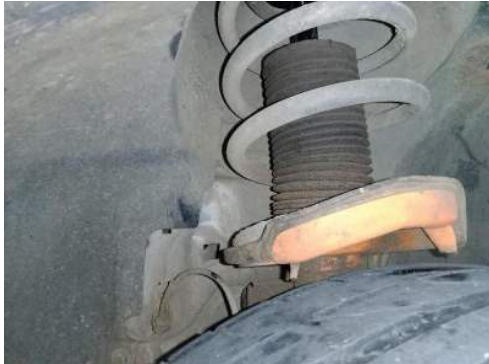
| Damage | Repair Way |
|---|---|
| Shock Absorber Front Right Leak | Replace |

| Damage | Repair Way |
|---|---|
| Front right shock absorber weak | Replace |

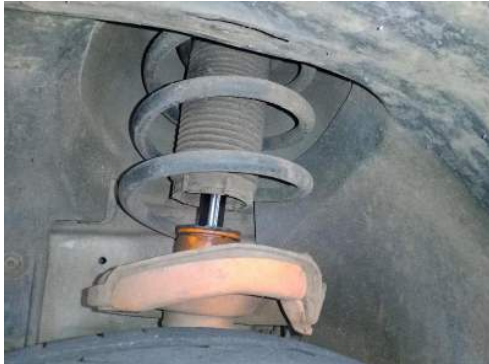
| Damage | Repair Way |
|---|---|
| Shock Absorber Front Left Sweat | Replace |

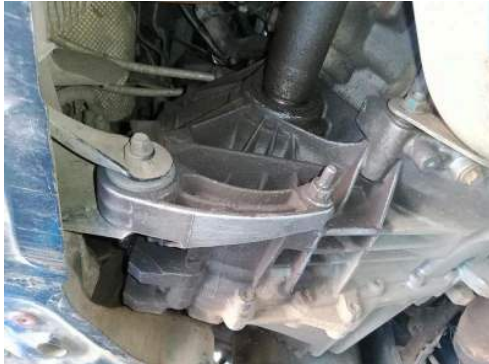
| Damage | Repair Way |
|---|---|
| Gearbox Oil Sweat | Repair |

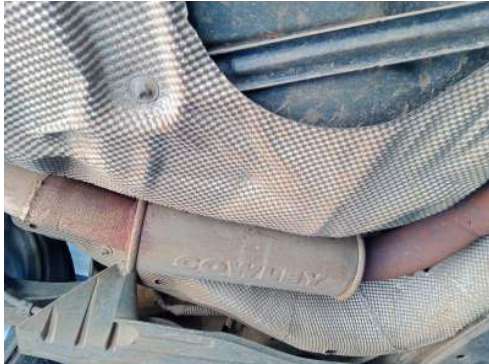
| Damage | Repair Way |
|---|---|
| Silencer Defective | Replace |

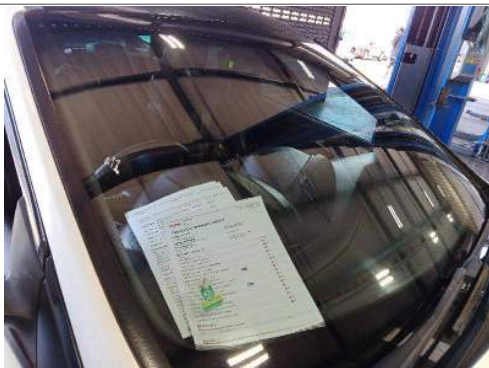
| Damage | Repair Way |
|---|---|
| Windscreen Chipped | Repair |

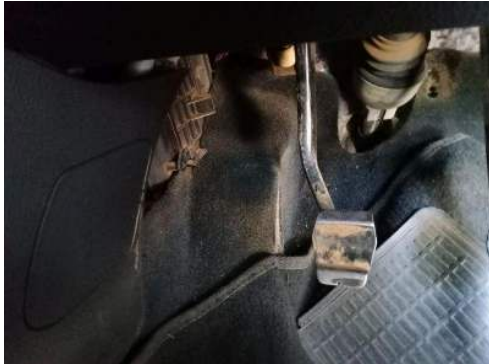
| Damage | Repair Way |
|---|---|
| Clutch Pedal Rubber Missing | Replace |

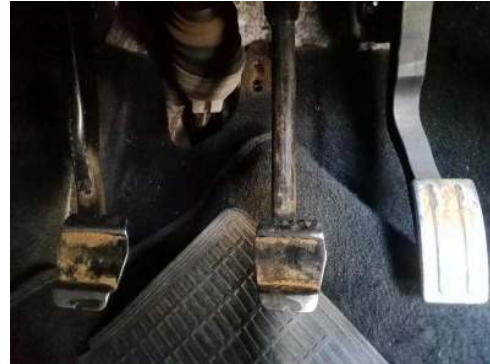
| Damage | Repair Way |
|---|---|
| Brake Pedal Rubber Missing | Replace |
