## CONDITION REPORT

Report No:  
2017301938  
DATE  
22/09/2026

| Manufacturer | FORD | Registration Number | YXM824GP |
| Model | FOCUS 2.5 ST 5-DR [2008-2012] | Register Number | |

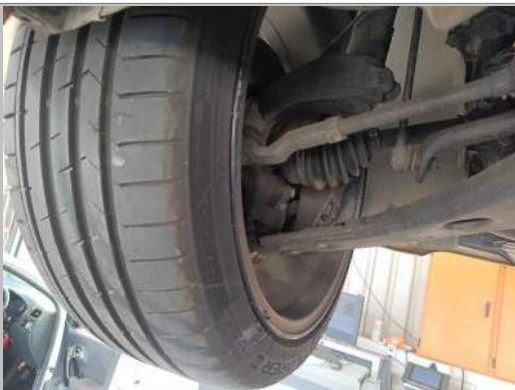
LF TYRE TREAD

| | Size | Load/Speed Index | Manufacture | Model | Type* | Production Date | Tread Depth (mm) |
|---|---|---|---|---|---|---|---|
| Front Left | 225/40R18 | 92Y | Royal Black | Explorer | V | 4425 | 6 mm |

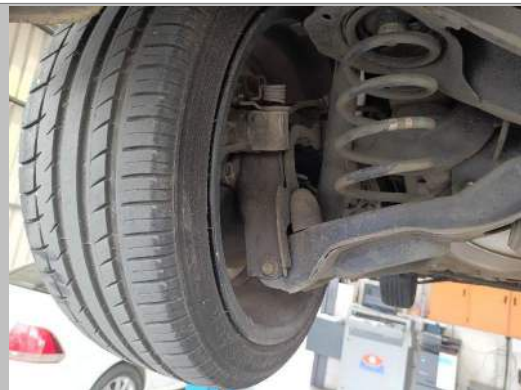
LR TYRE TREAD

| | Size | Load/Speed Index | Manufacture | Model | Type* | Production Date | Tread Depth (mm) |
|---|---|---|---|---|---|---|---|
| Rear Left | 225/40R18 | 92Y | Diamond Blac | DSH | V | 2821 | 6 mm |

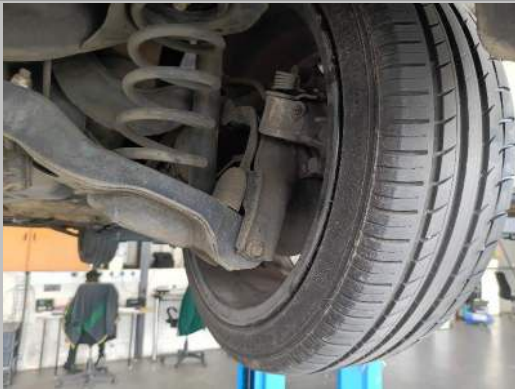
RR TYRE TREAD

| | Size | Load/Speed Index | Manufacture | Model | Type* | Production Date | Tread Depth (mm) |
|---|---|---|---|---|---|---|---|
| Rear Right | 225/40R18 | 92H | Diamond Blac | DSH | V | 2821 | 6 mm |

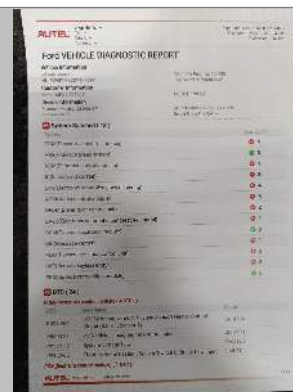
DIAGNOSTIC REPORT PAGE 1

| No | System | Code | Description | Status |
|---|---|---|---|---|
| 1 | RESTRAINT CONTROL MODULE | B1318-20 | BATTERY VOLTAGE TOO LOW | |
| 2 | MESSAGE CENTER | B1389-20 | OIL TEMPERATURE SENSOR CIRCUIT FAILURE | |

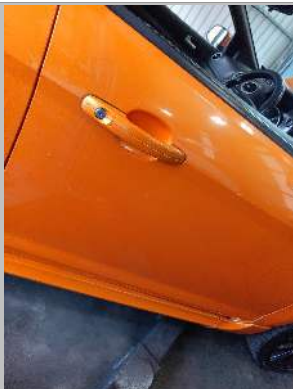
| Door Front Right Paintwork • Flaking | Repair |

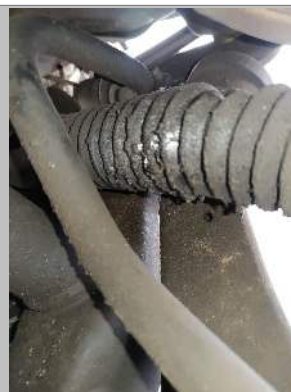
| Steering Rack Boot Left Leak | Replace |

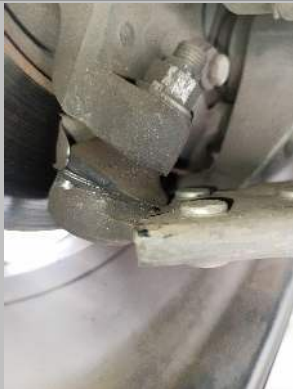
| Ball Joint(s) Front Axle Left Damaged | Replace |

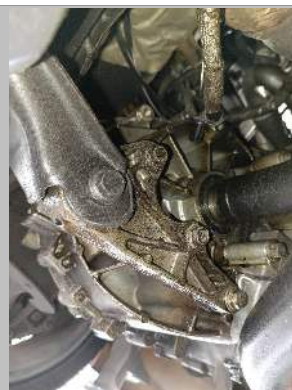
| Gearbox Mountings Cracked | Replace |
| Gearbox Oil Leak | Repair |
